Report of Inspection

South Hams / West Devon Park Inspection Report

Site name: Harbertonford

Date of Inspection: 08/06/2022

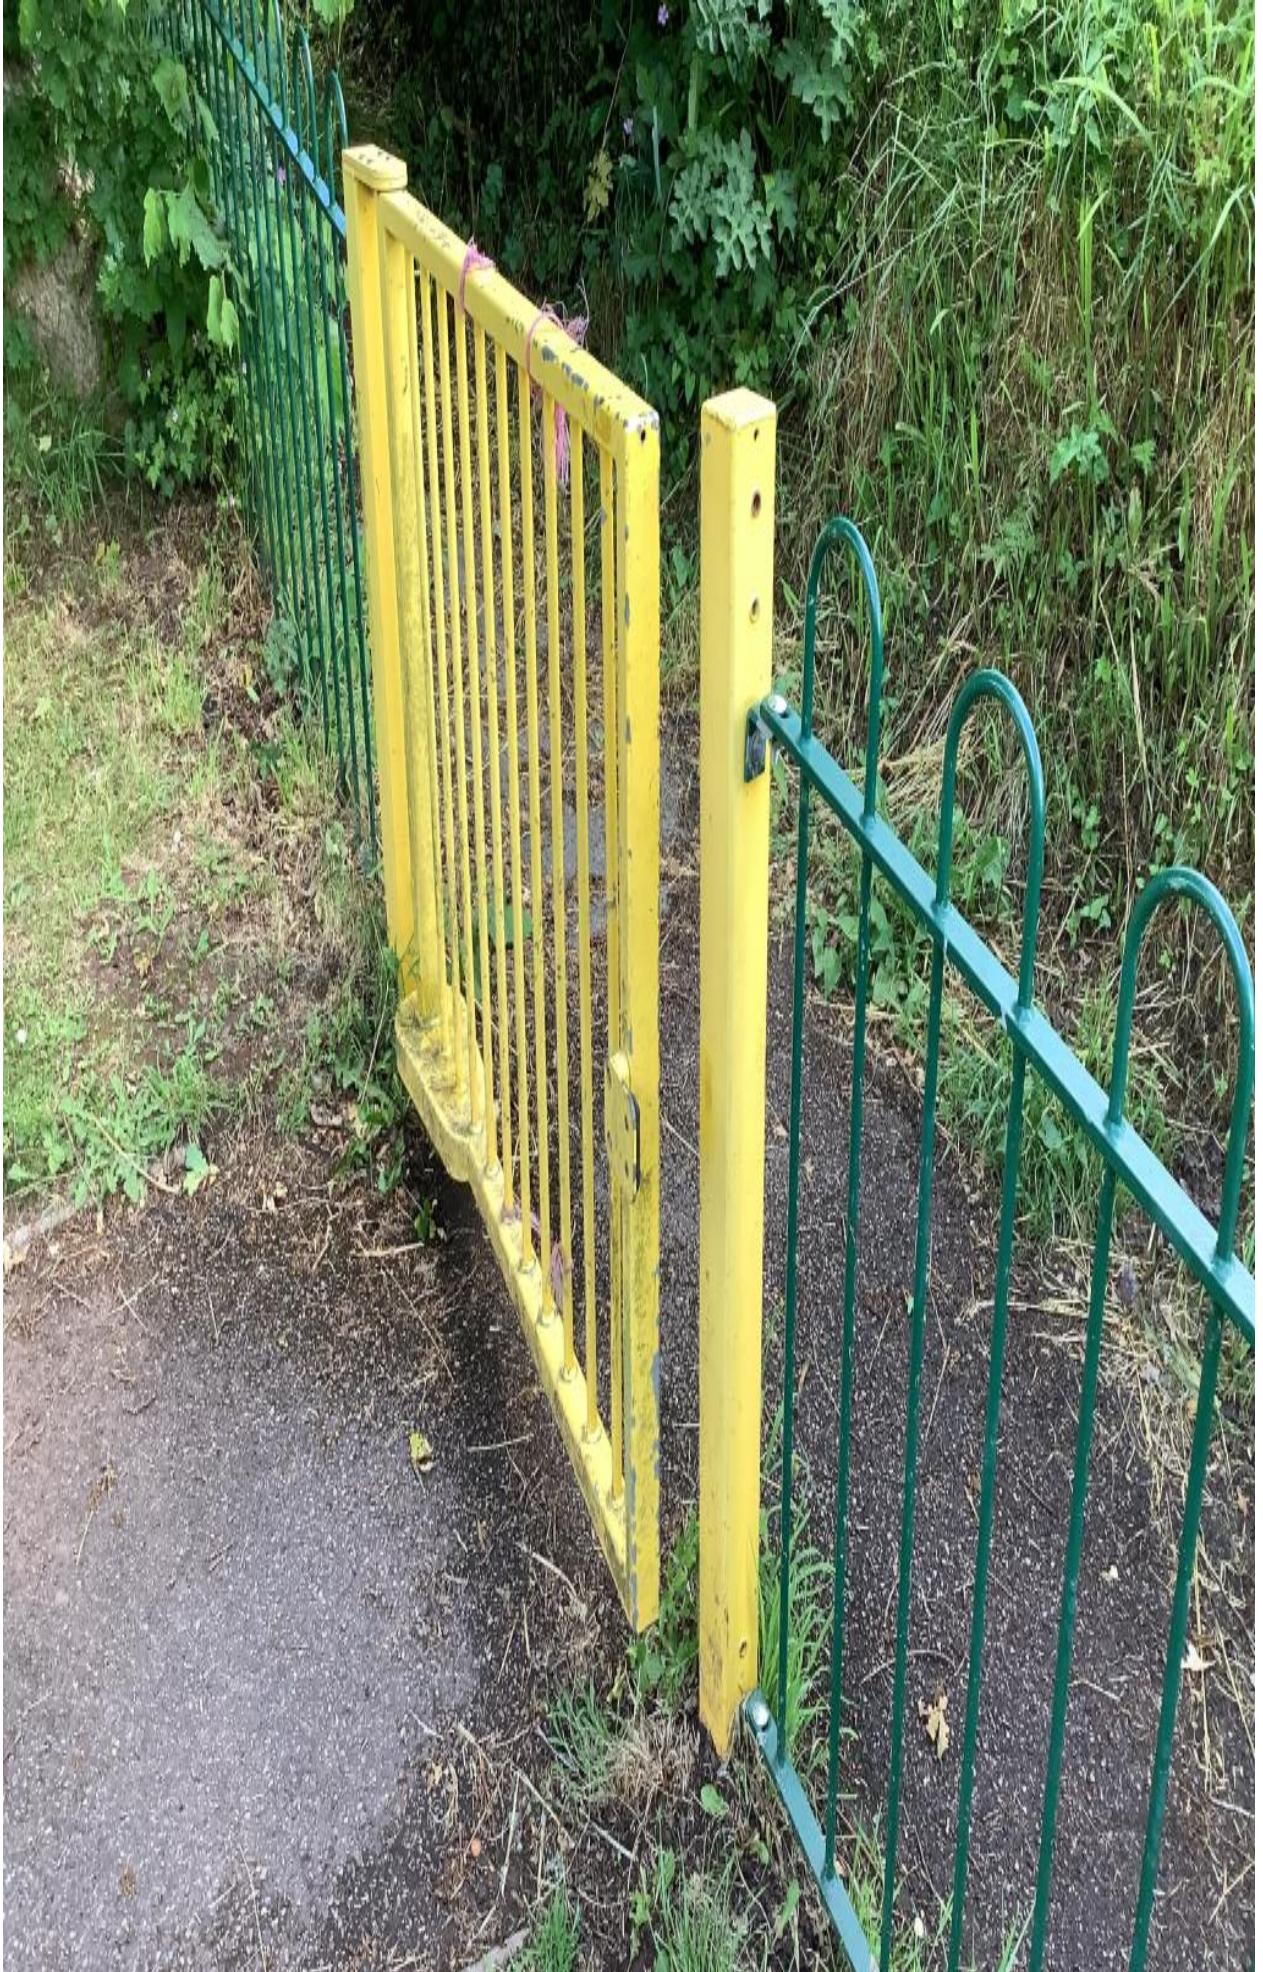
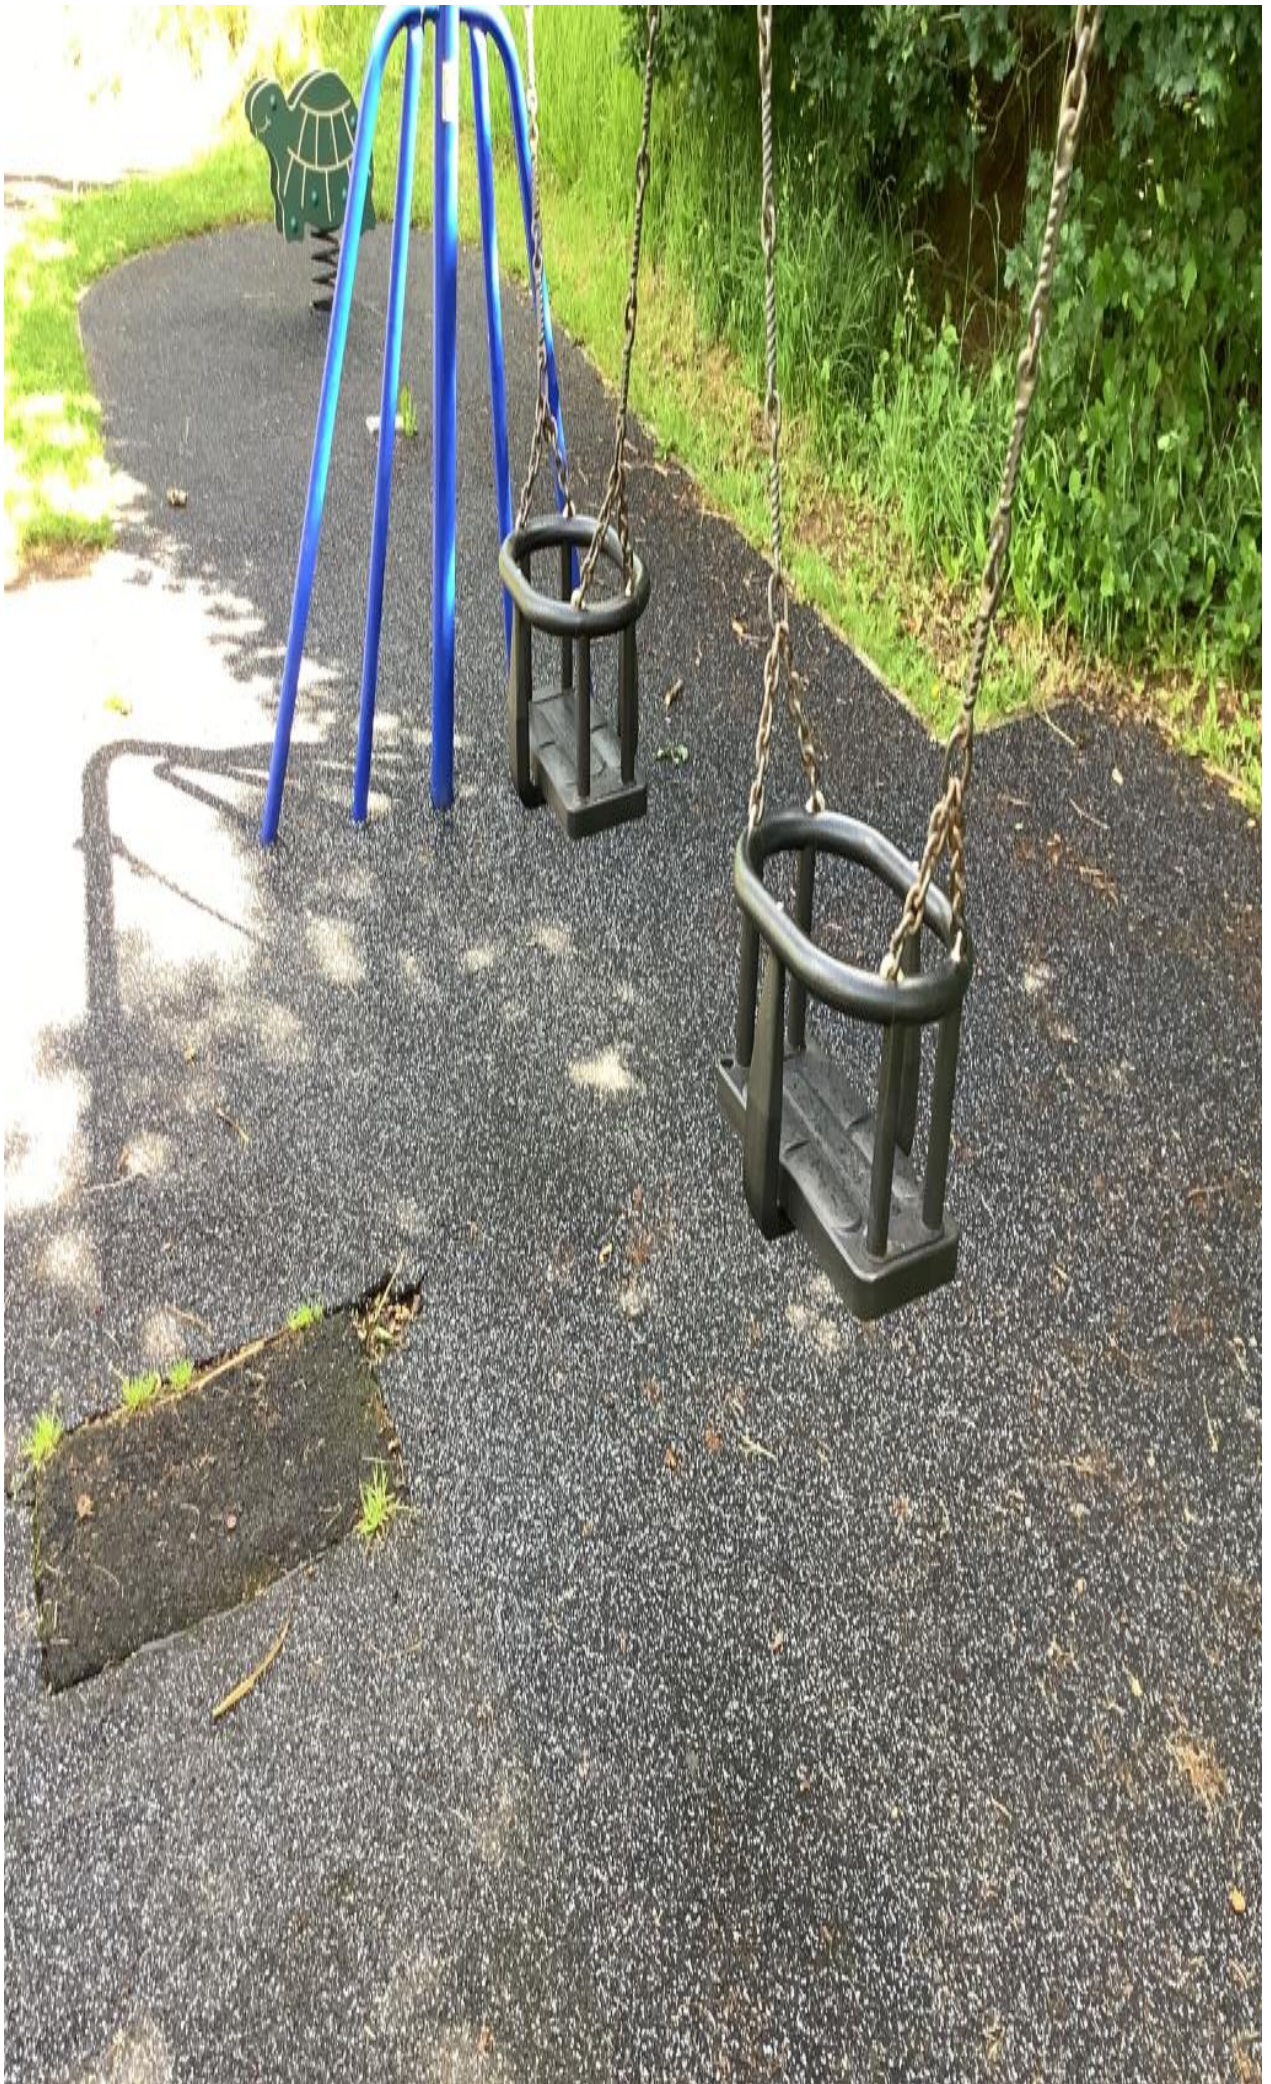
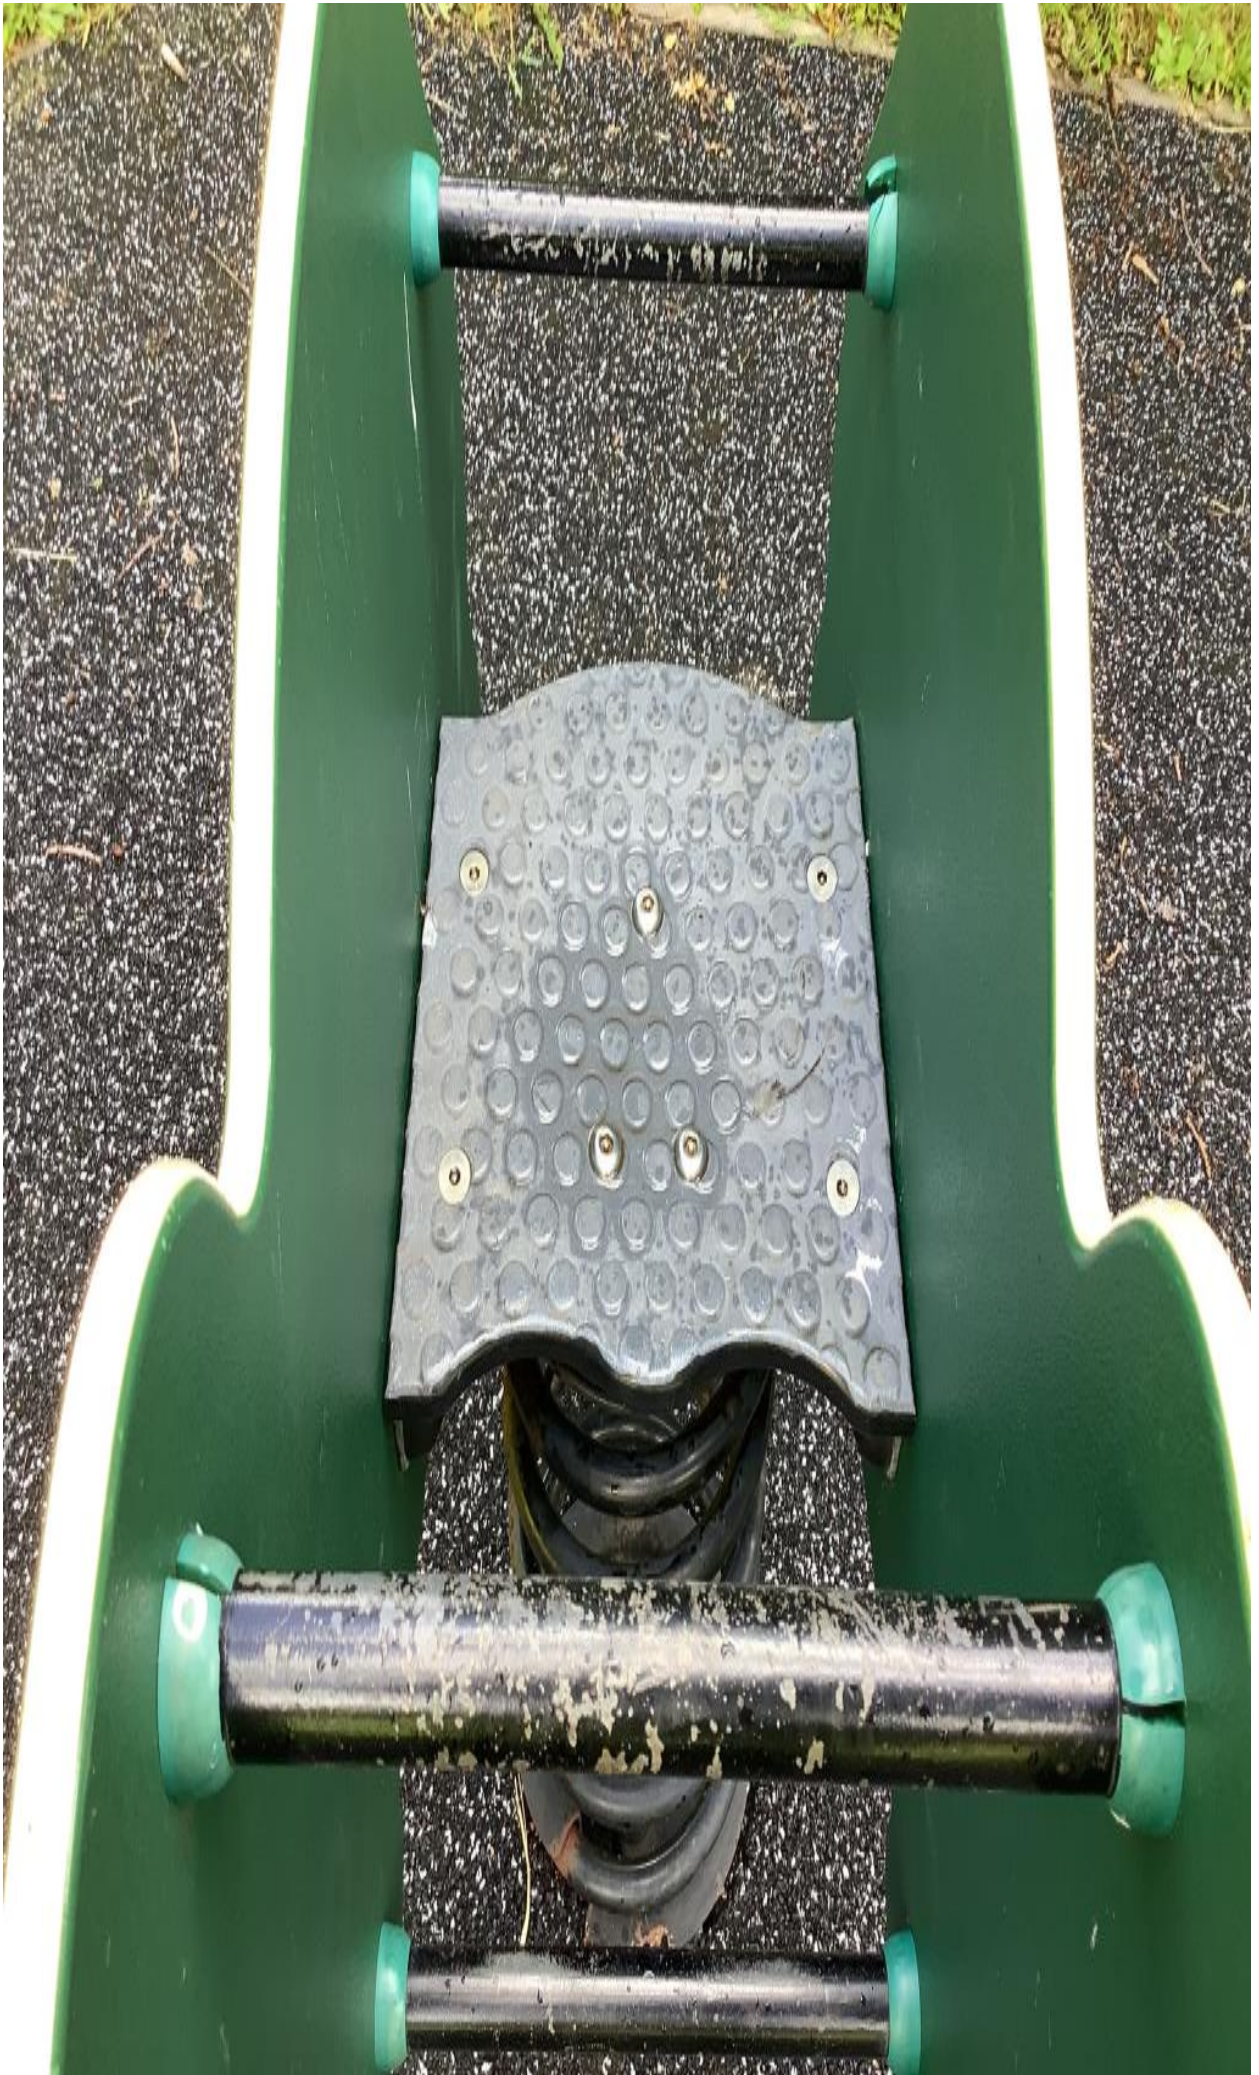
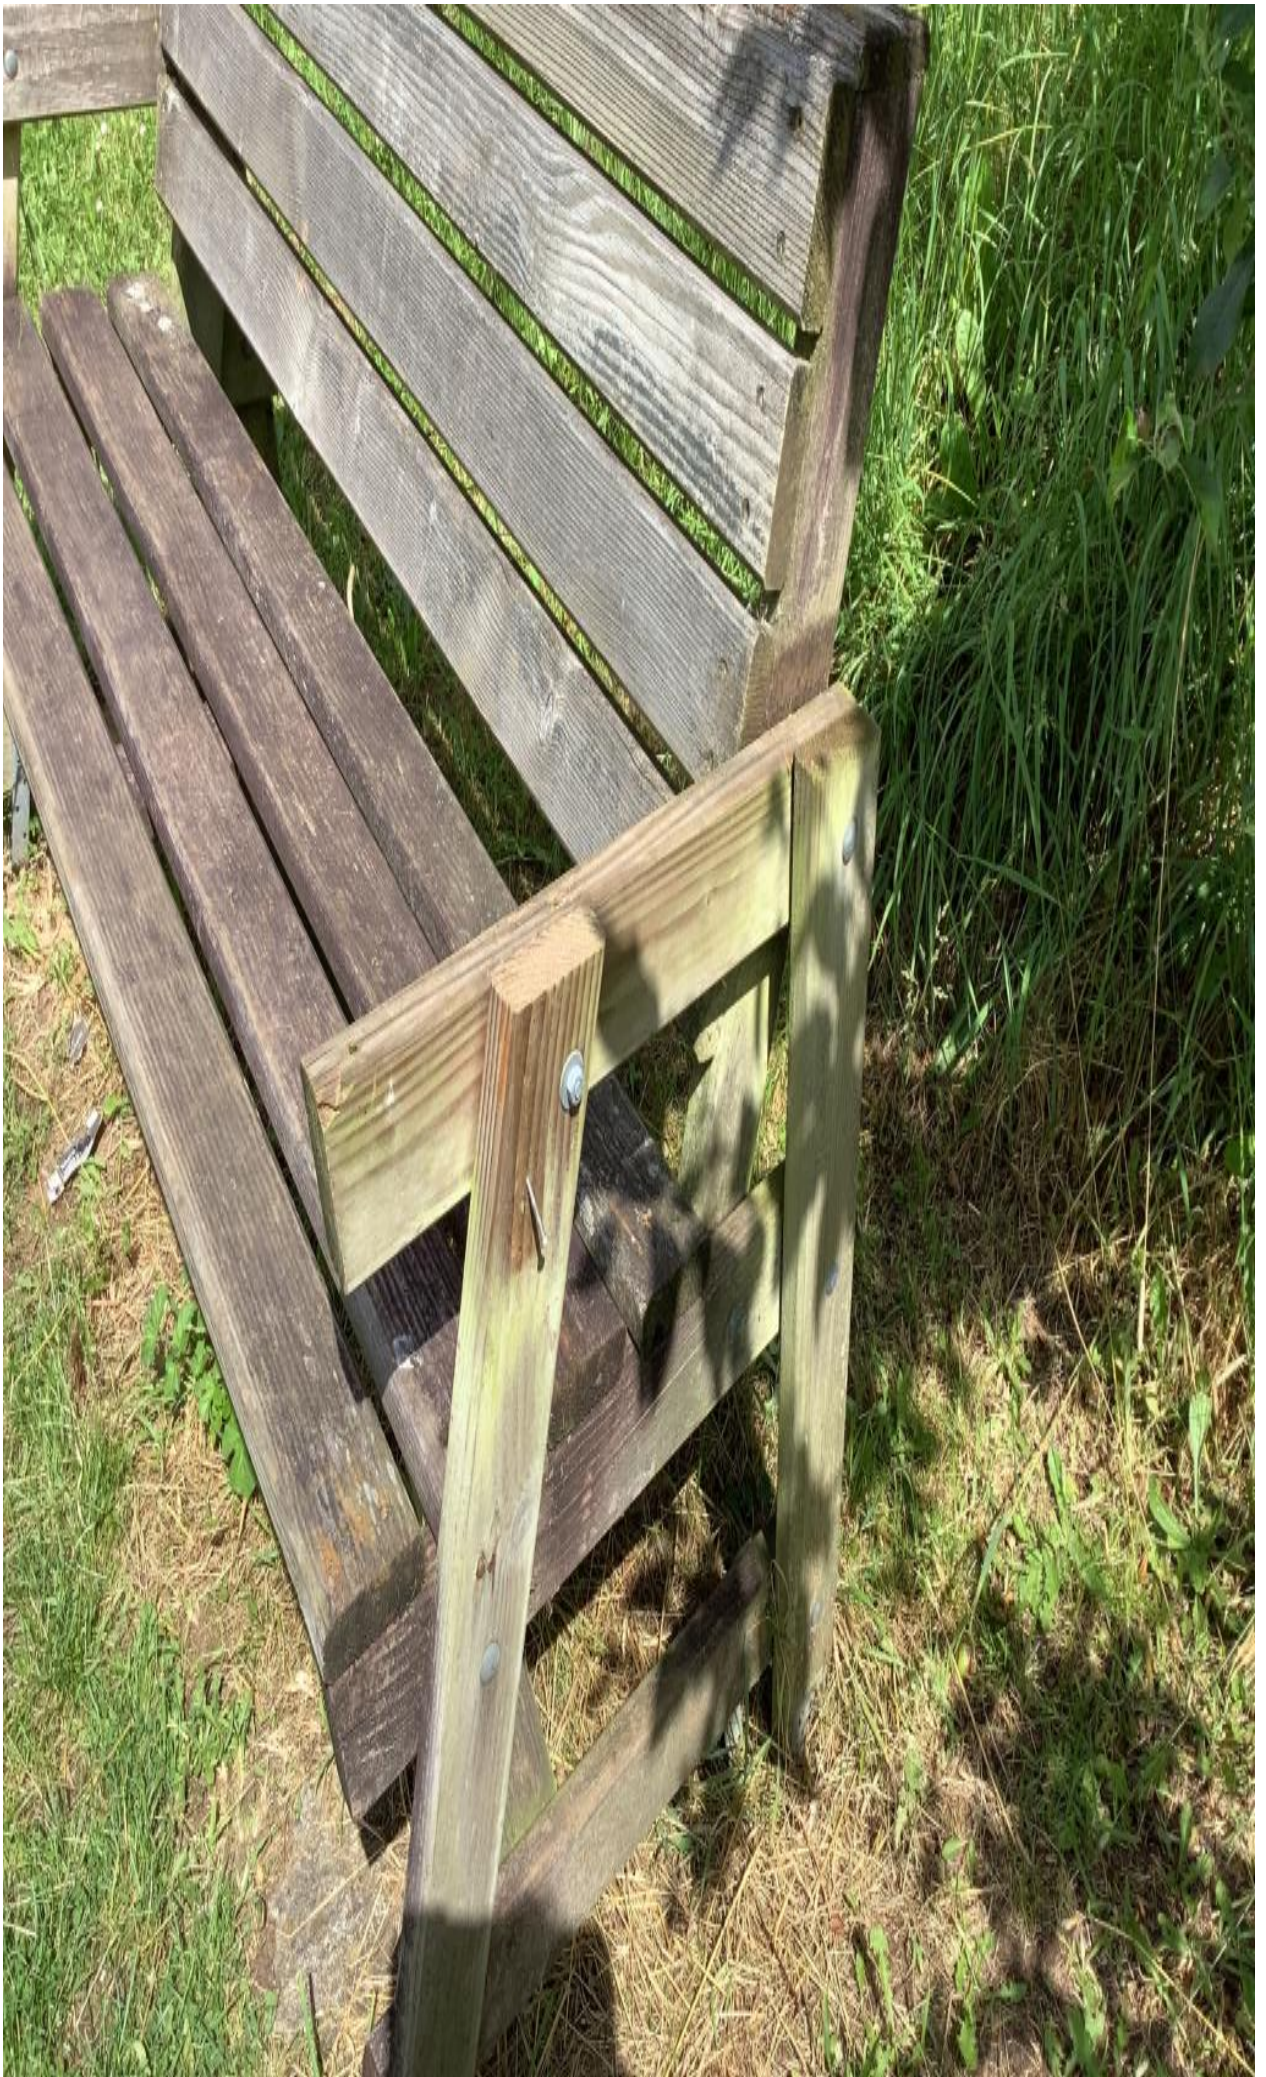
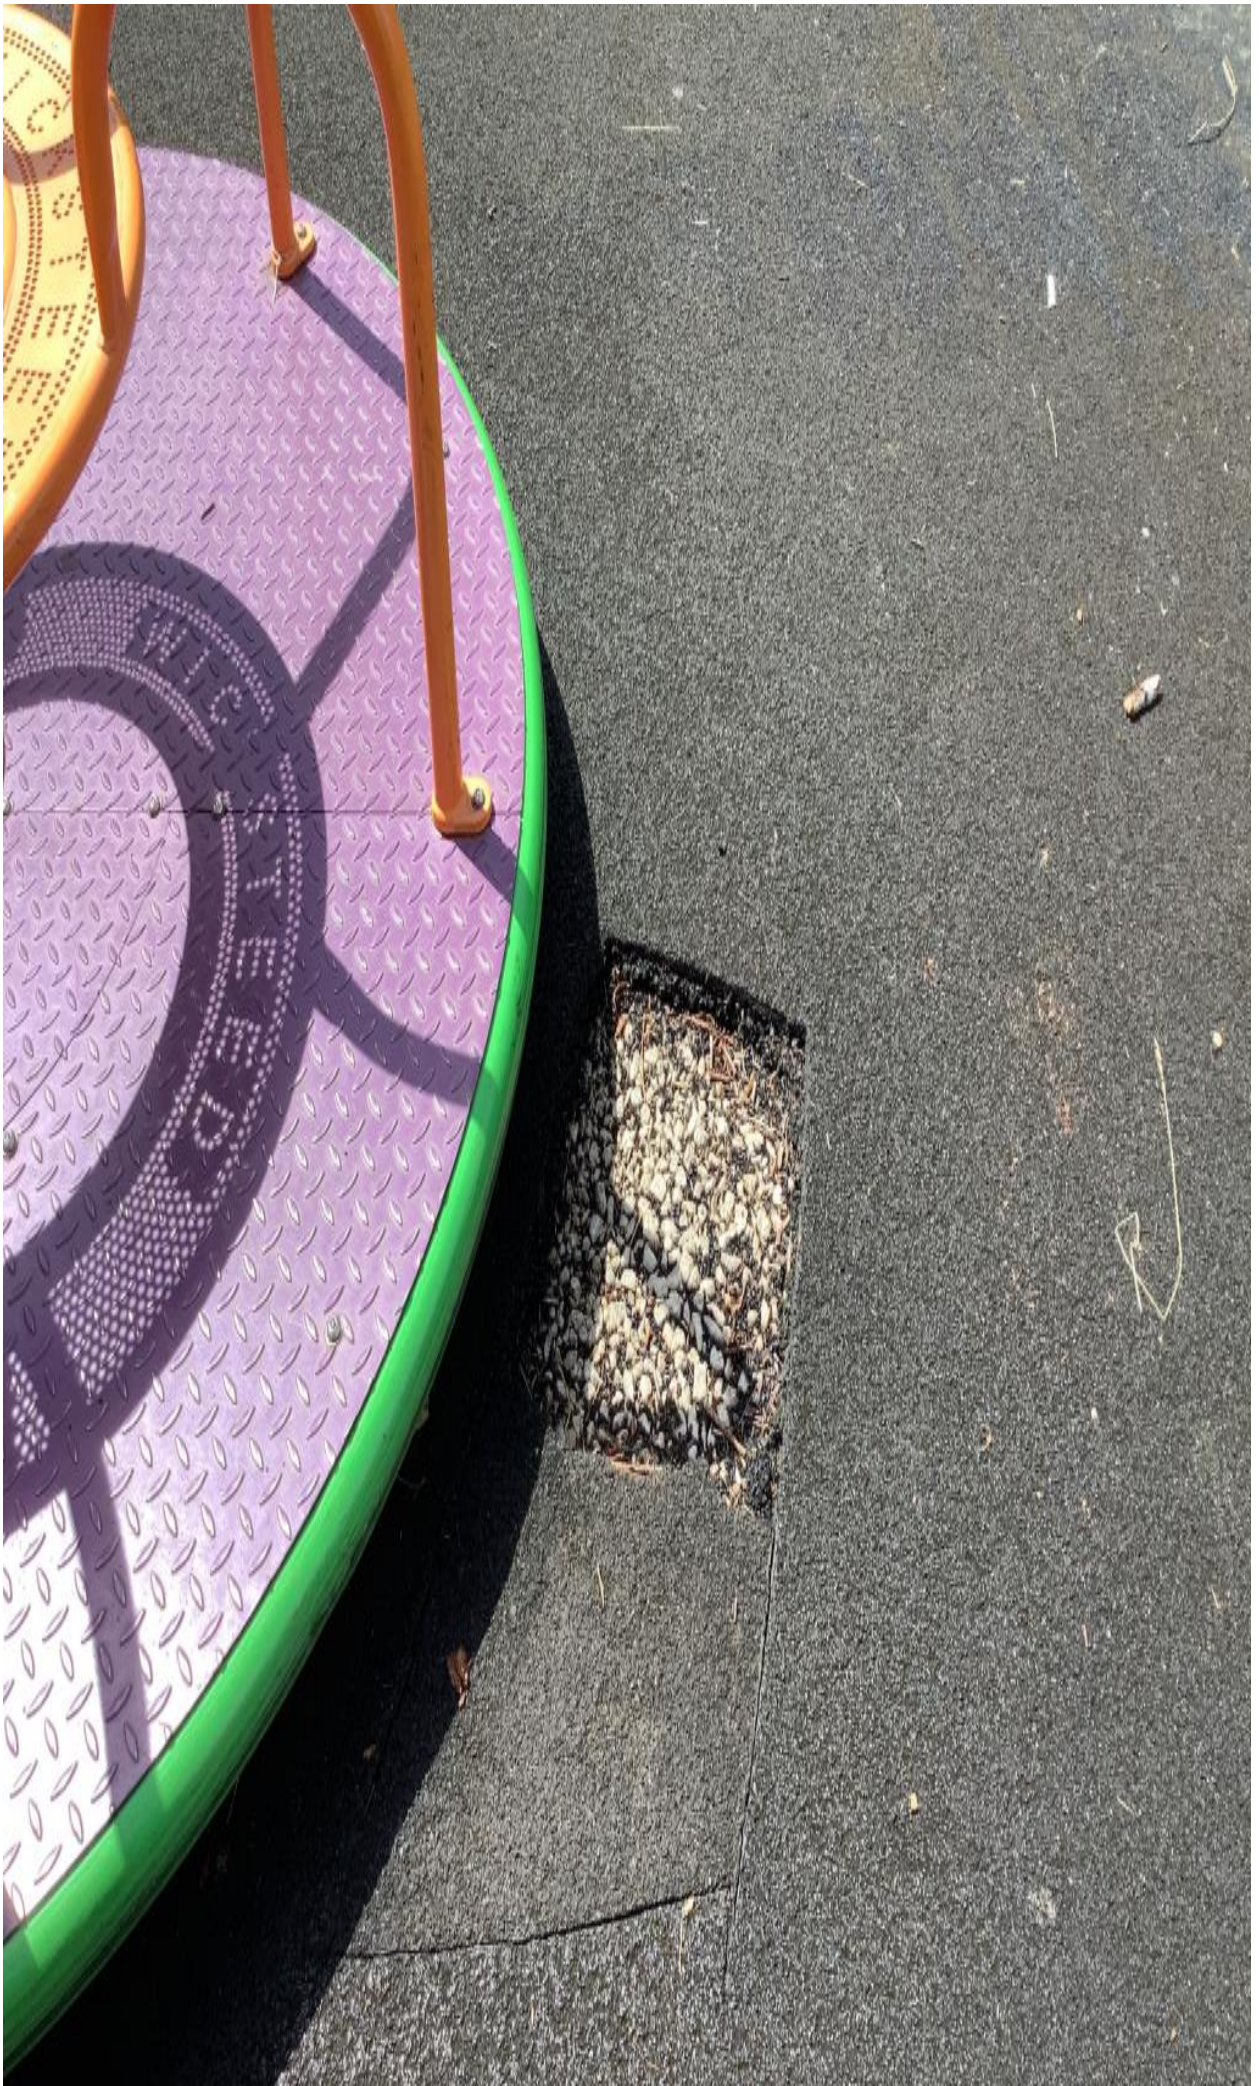
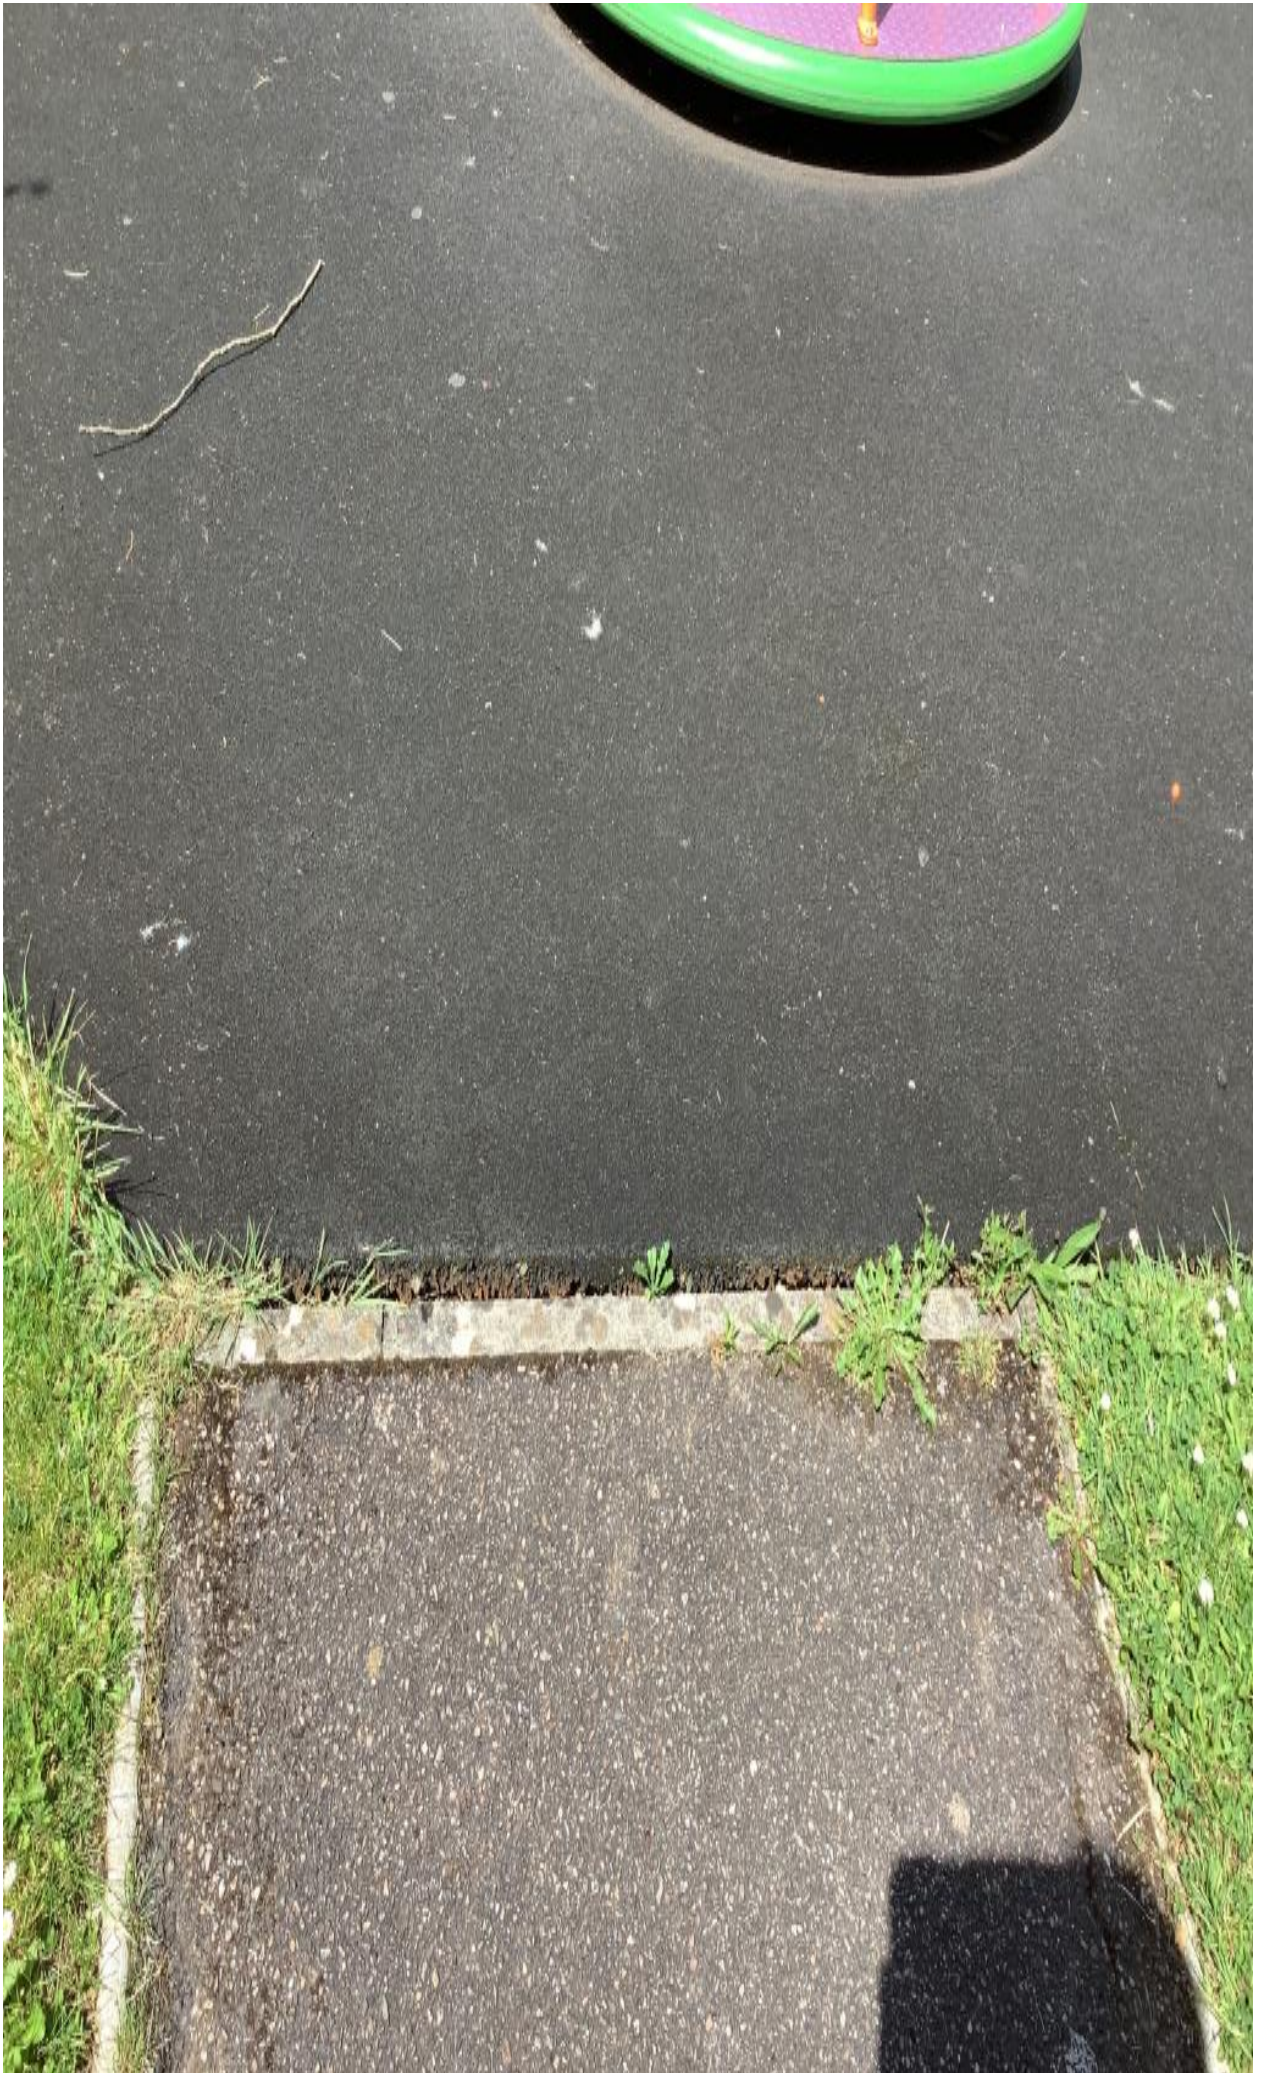
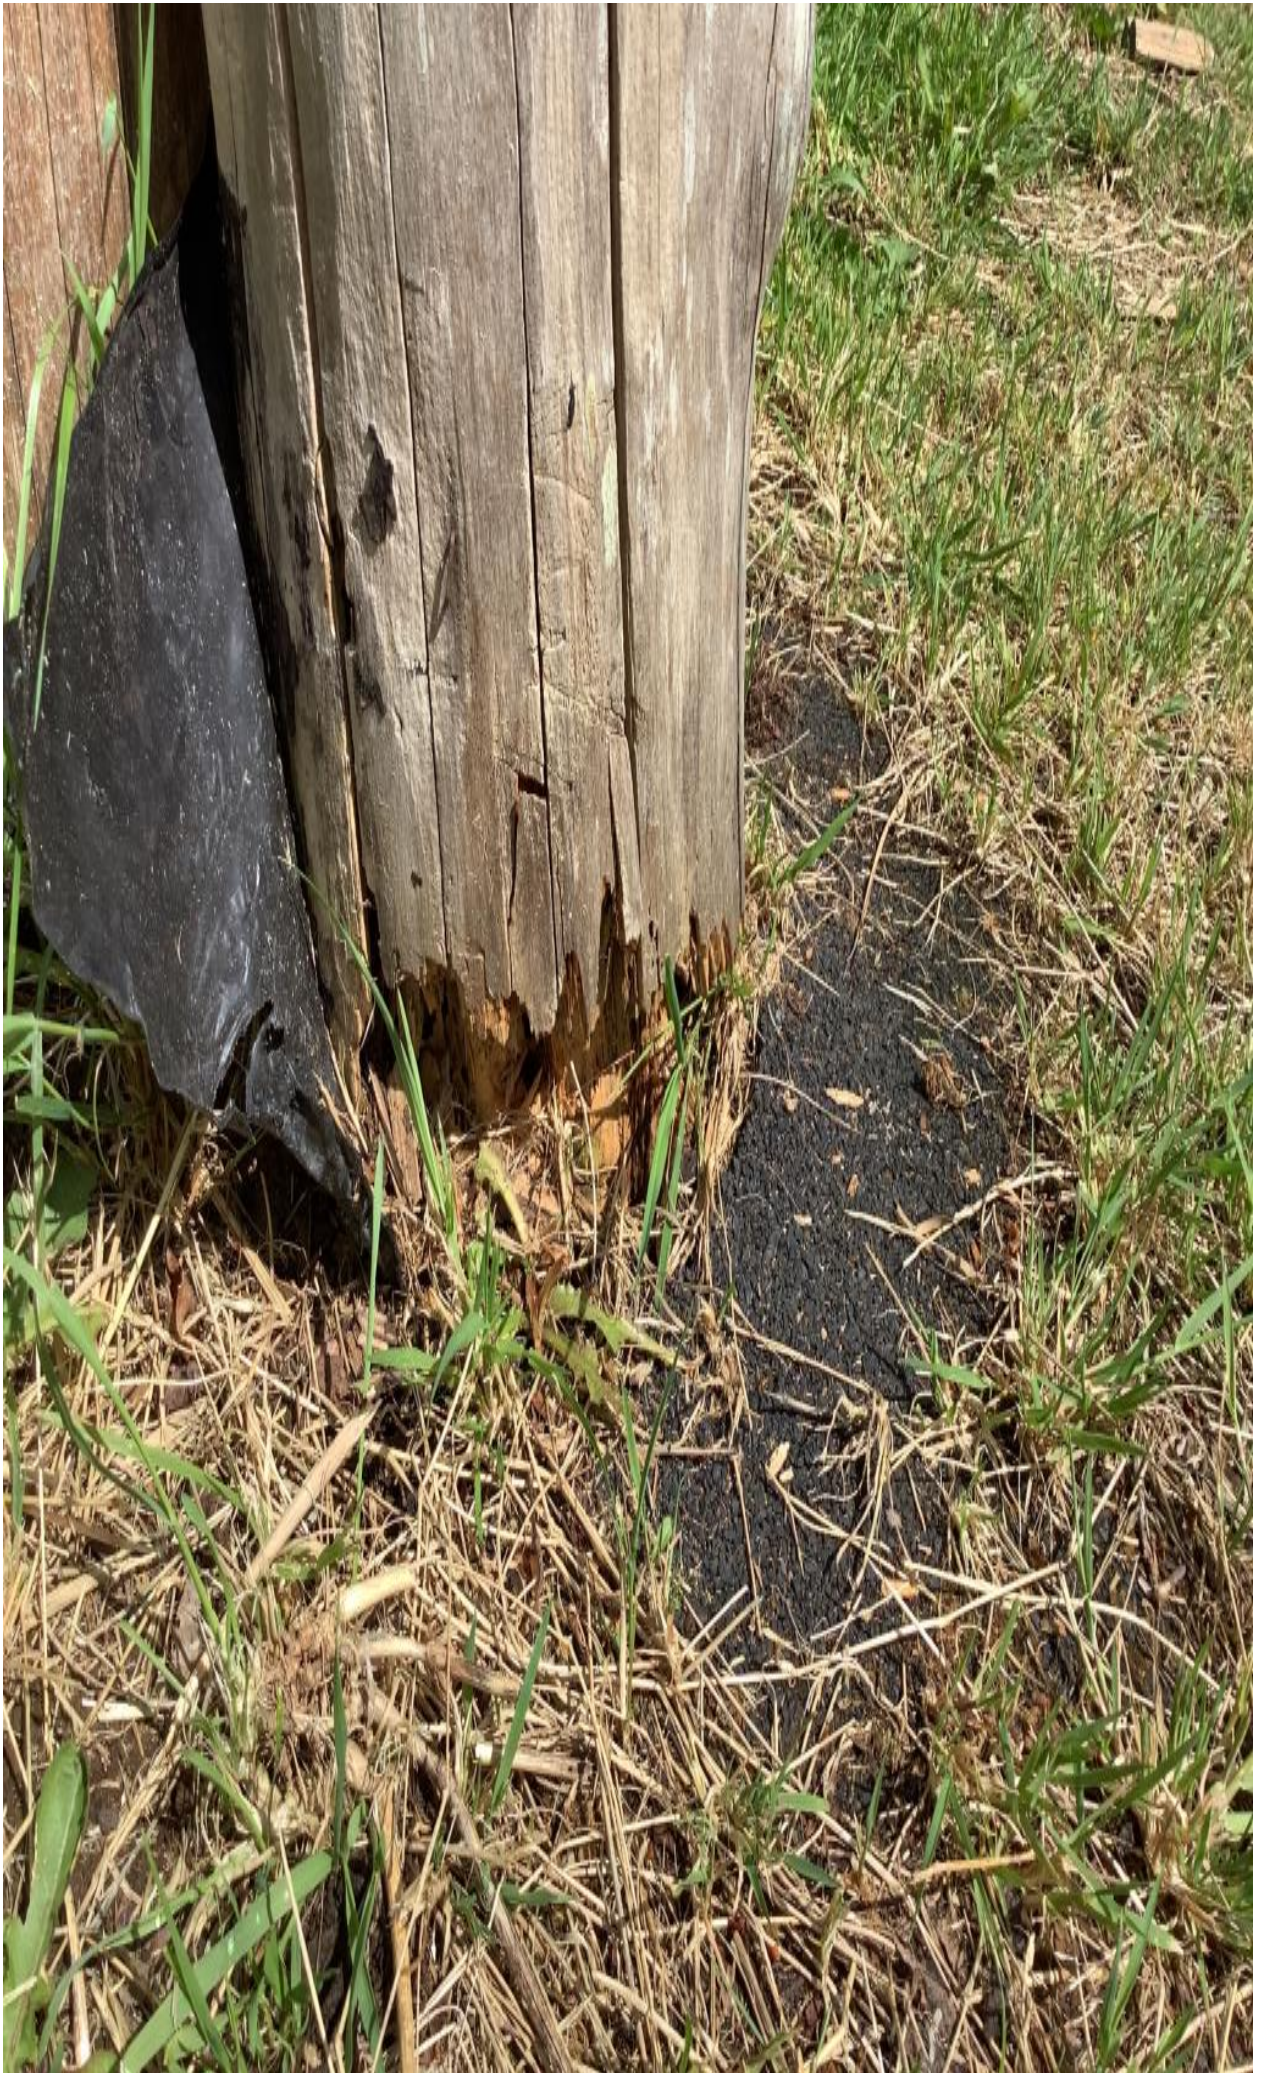
Photographs of Inspection

Entrance gate does not close fully.
Hole in safety Matting next to small swing set.
Split plastic brackets on sprung tortoise causing sharp edges.
Screw sticking out of wooden bench.
Missing safety matting next to roundabout leaving concrete.
Rubber safety matting lifting causing trip hazards.
Rotten posts to monkey bars and climbing posts

Missing fencing around the lower side boundary of the park causing unsafe areas.
