South Hams / West Devon Park Inspection Report

Ref: AOM3492406

Site name: Harbertonford

Date of Inspection: 27/07/2022

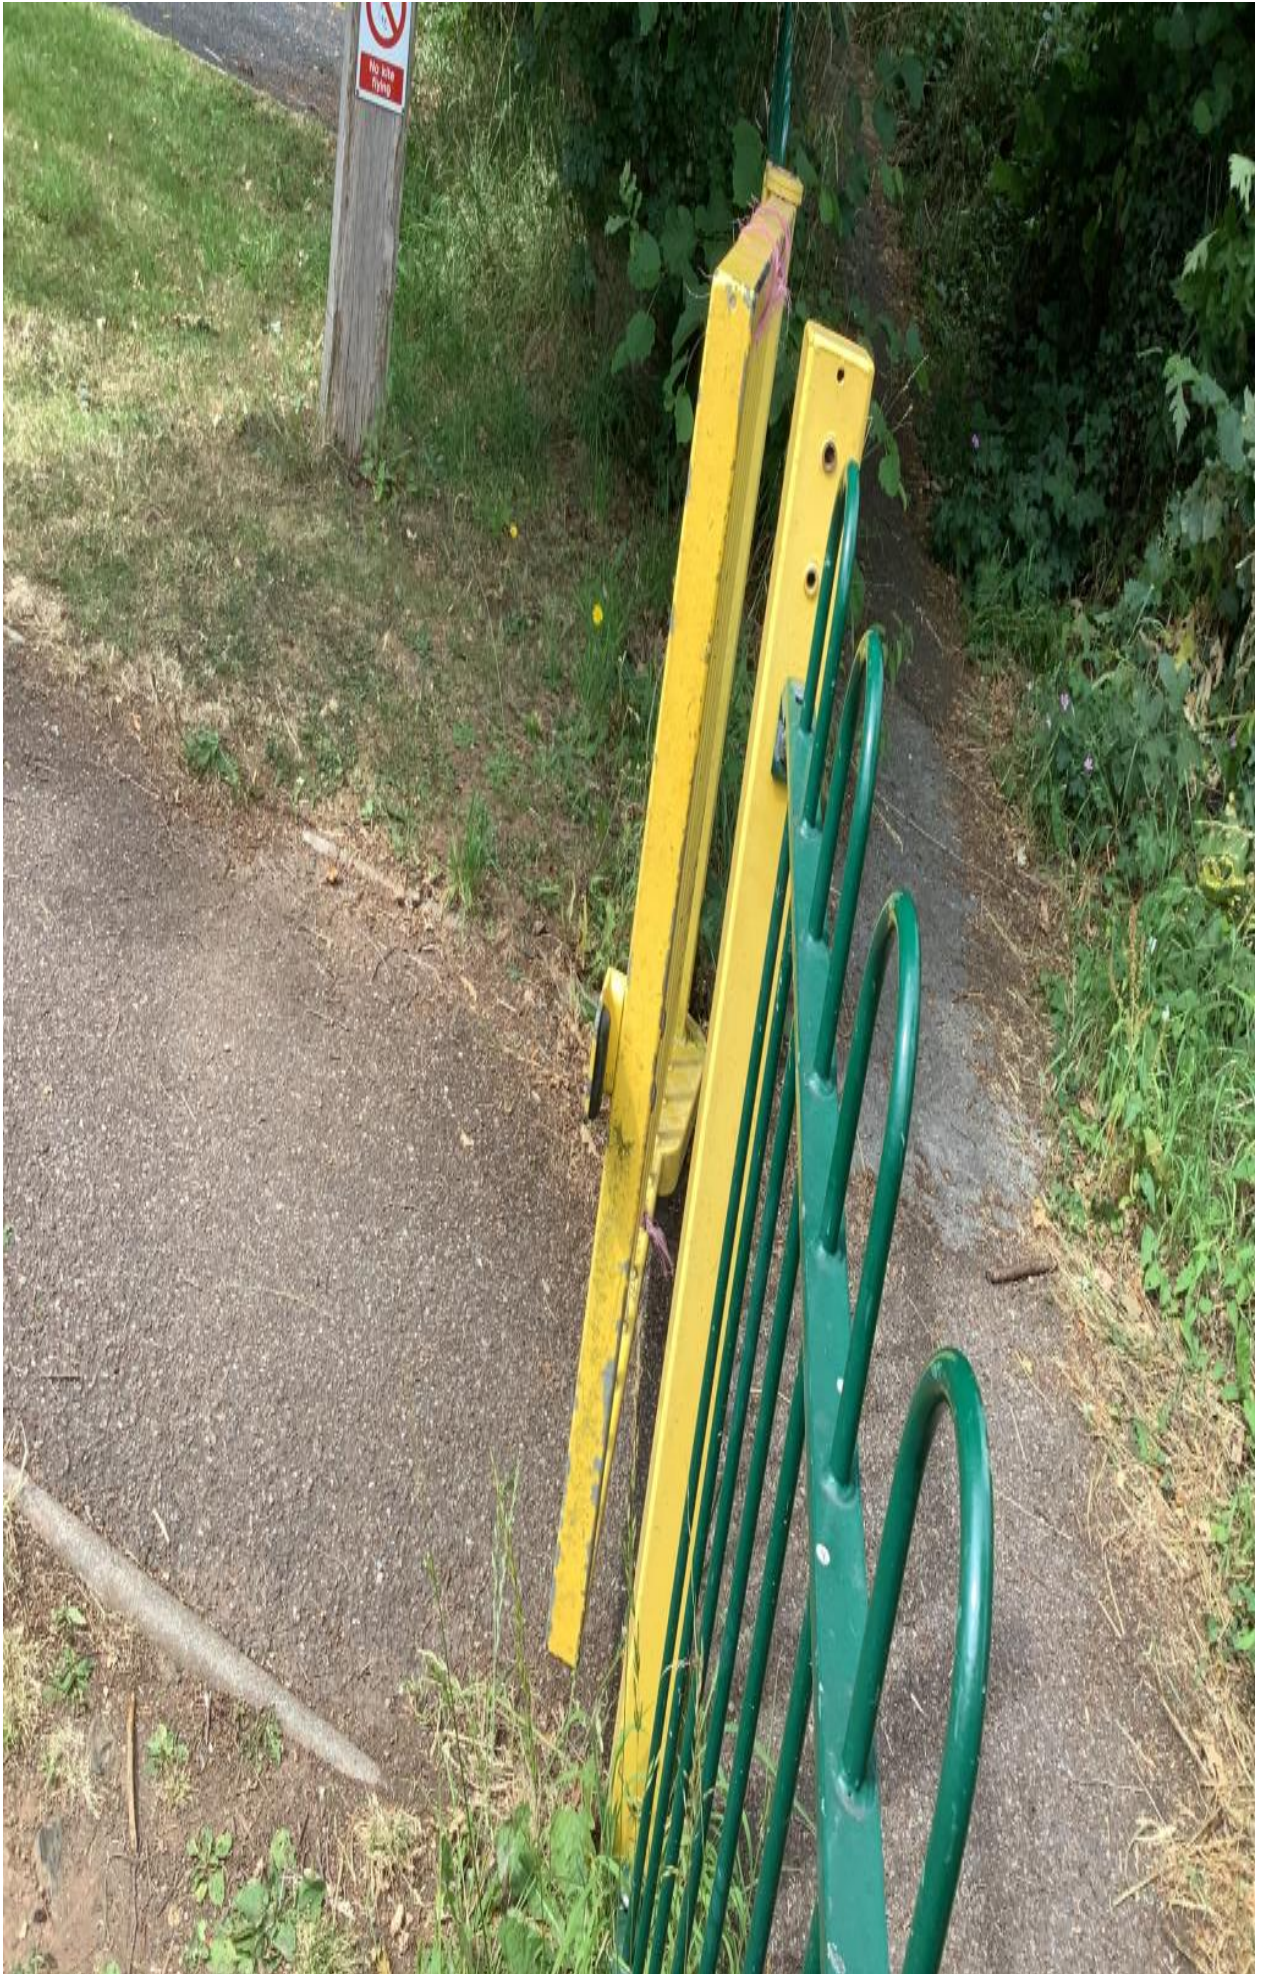
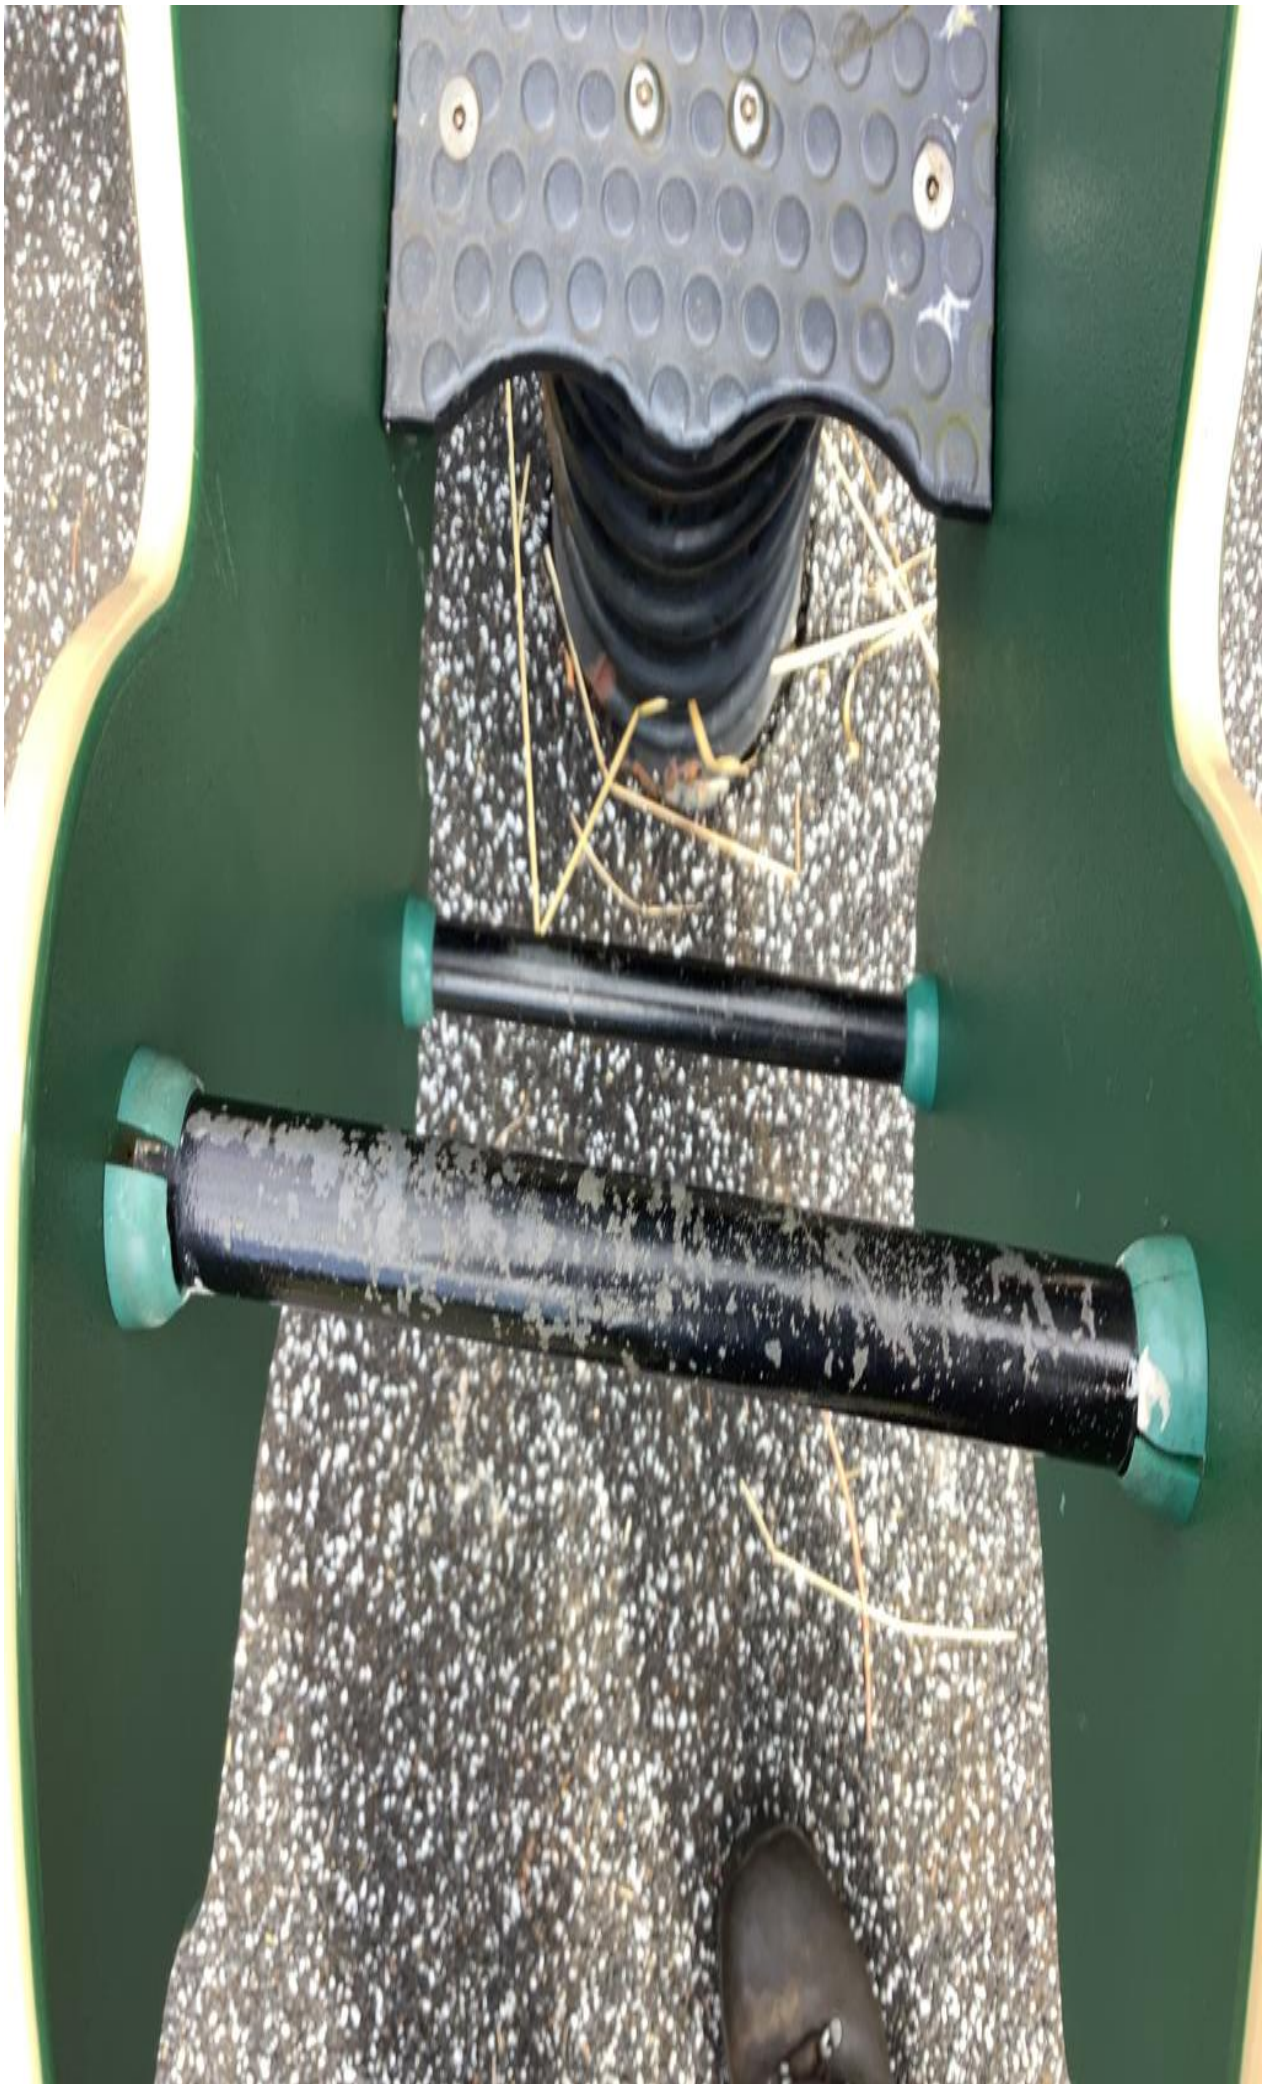
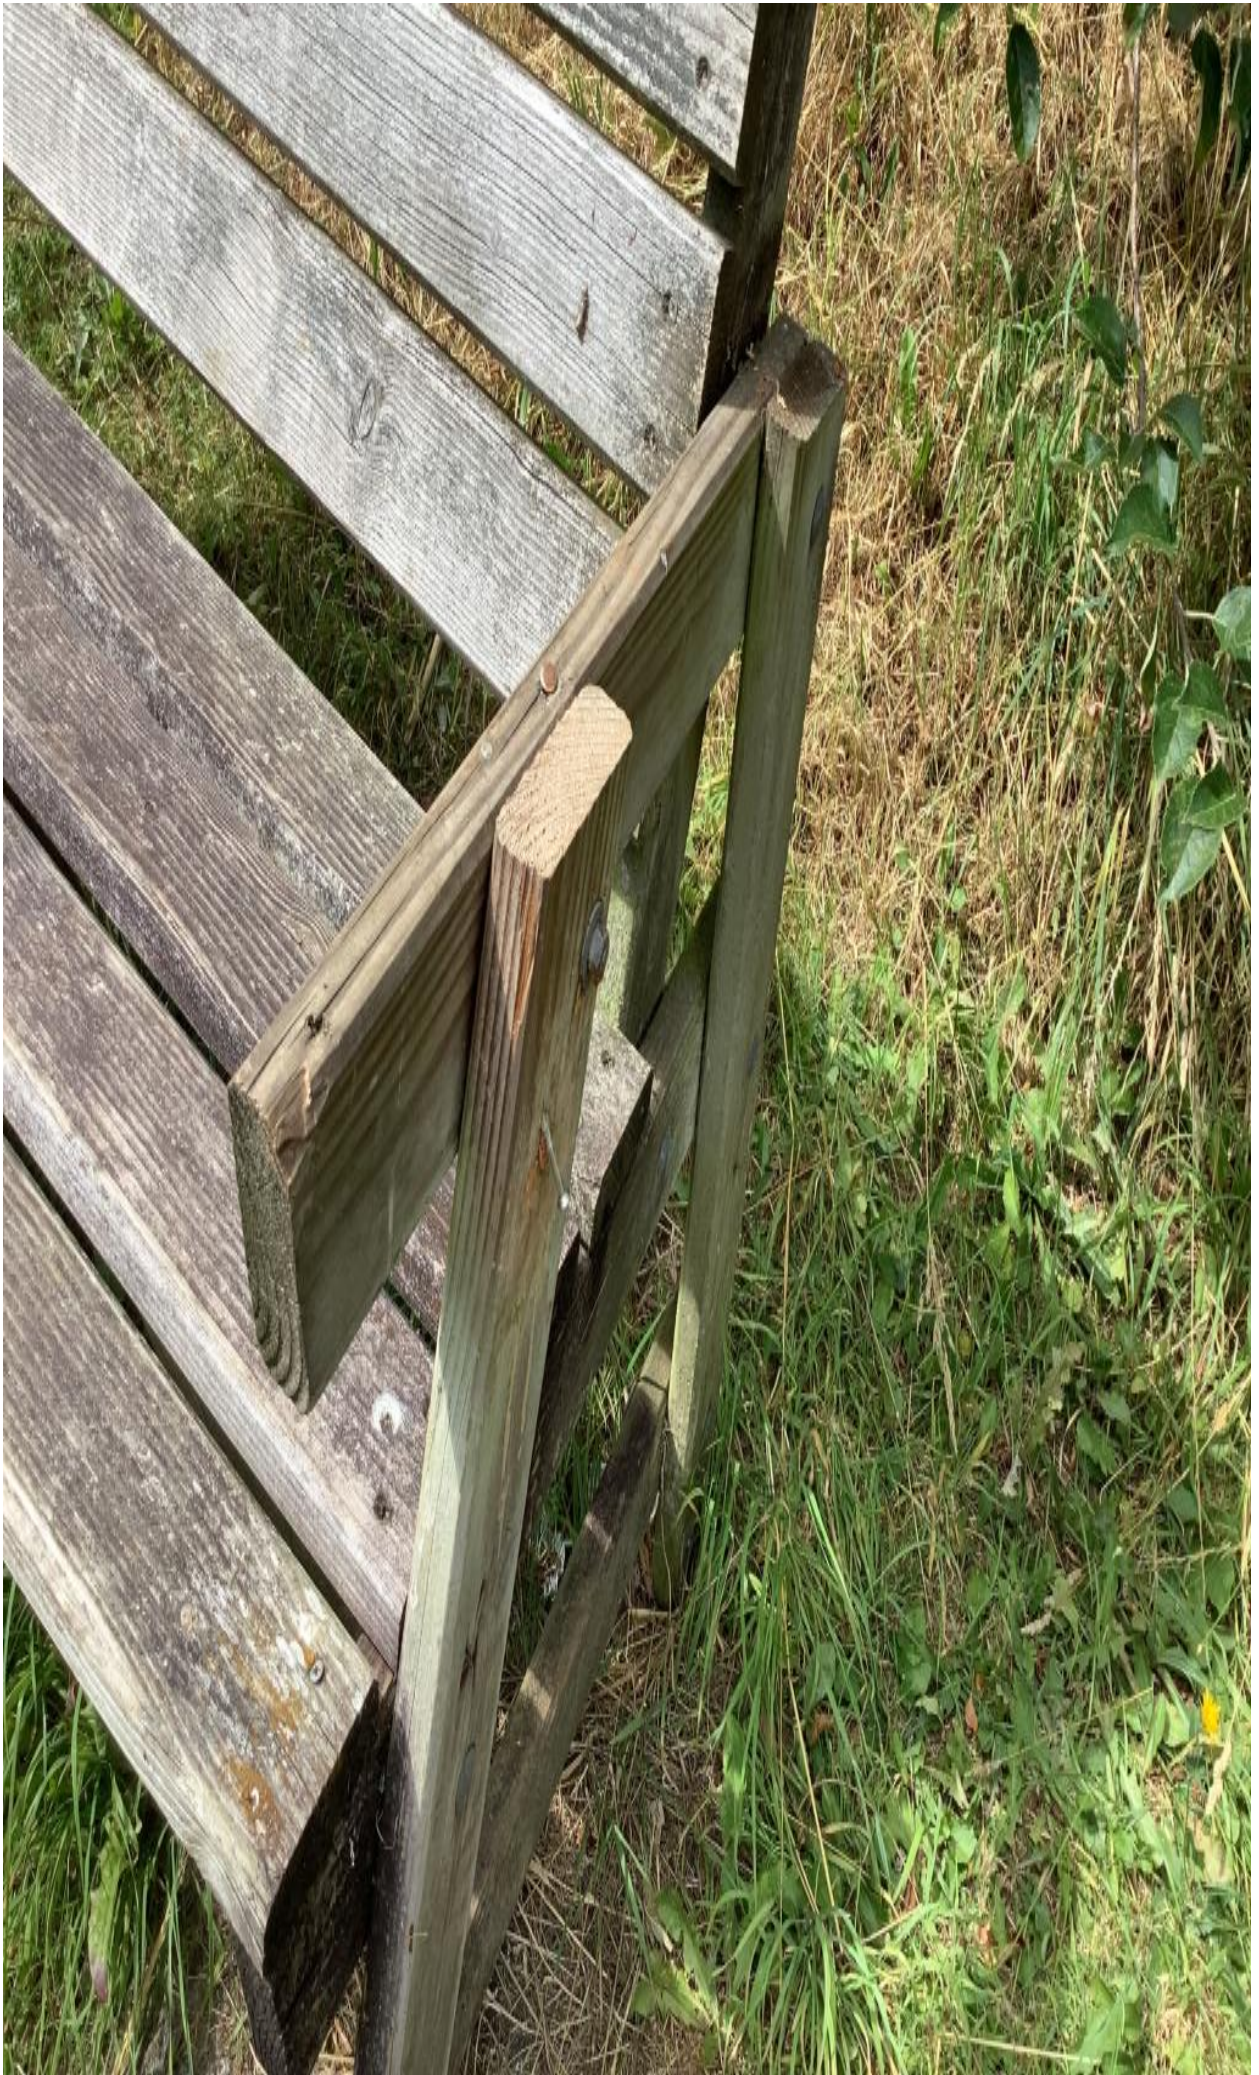
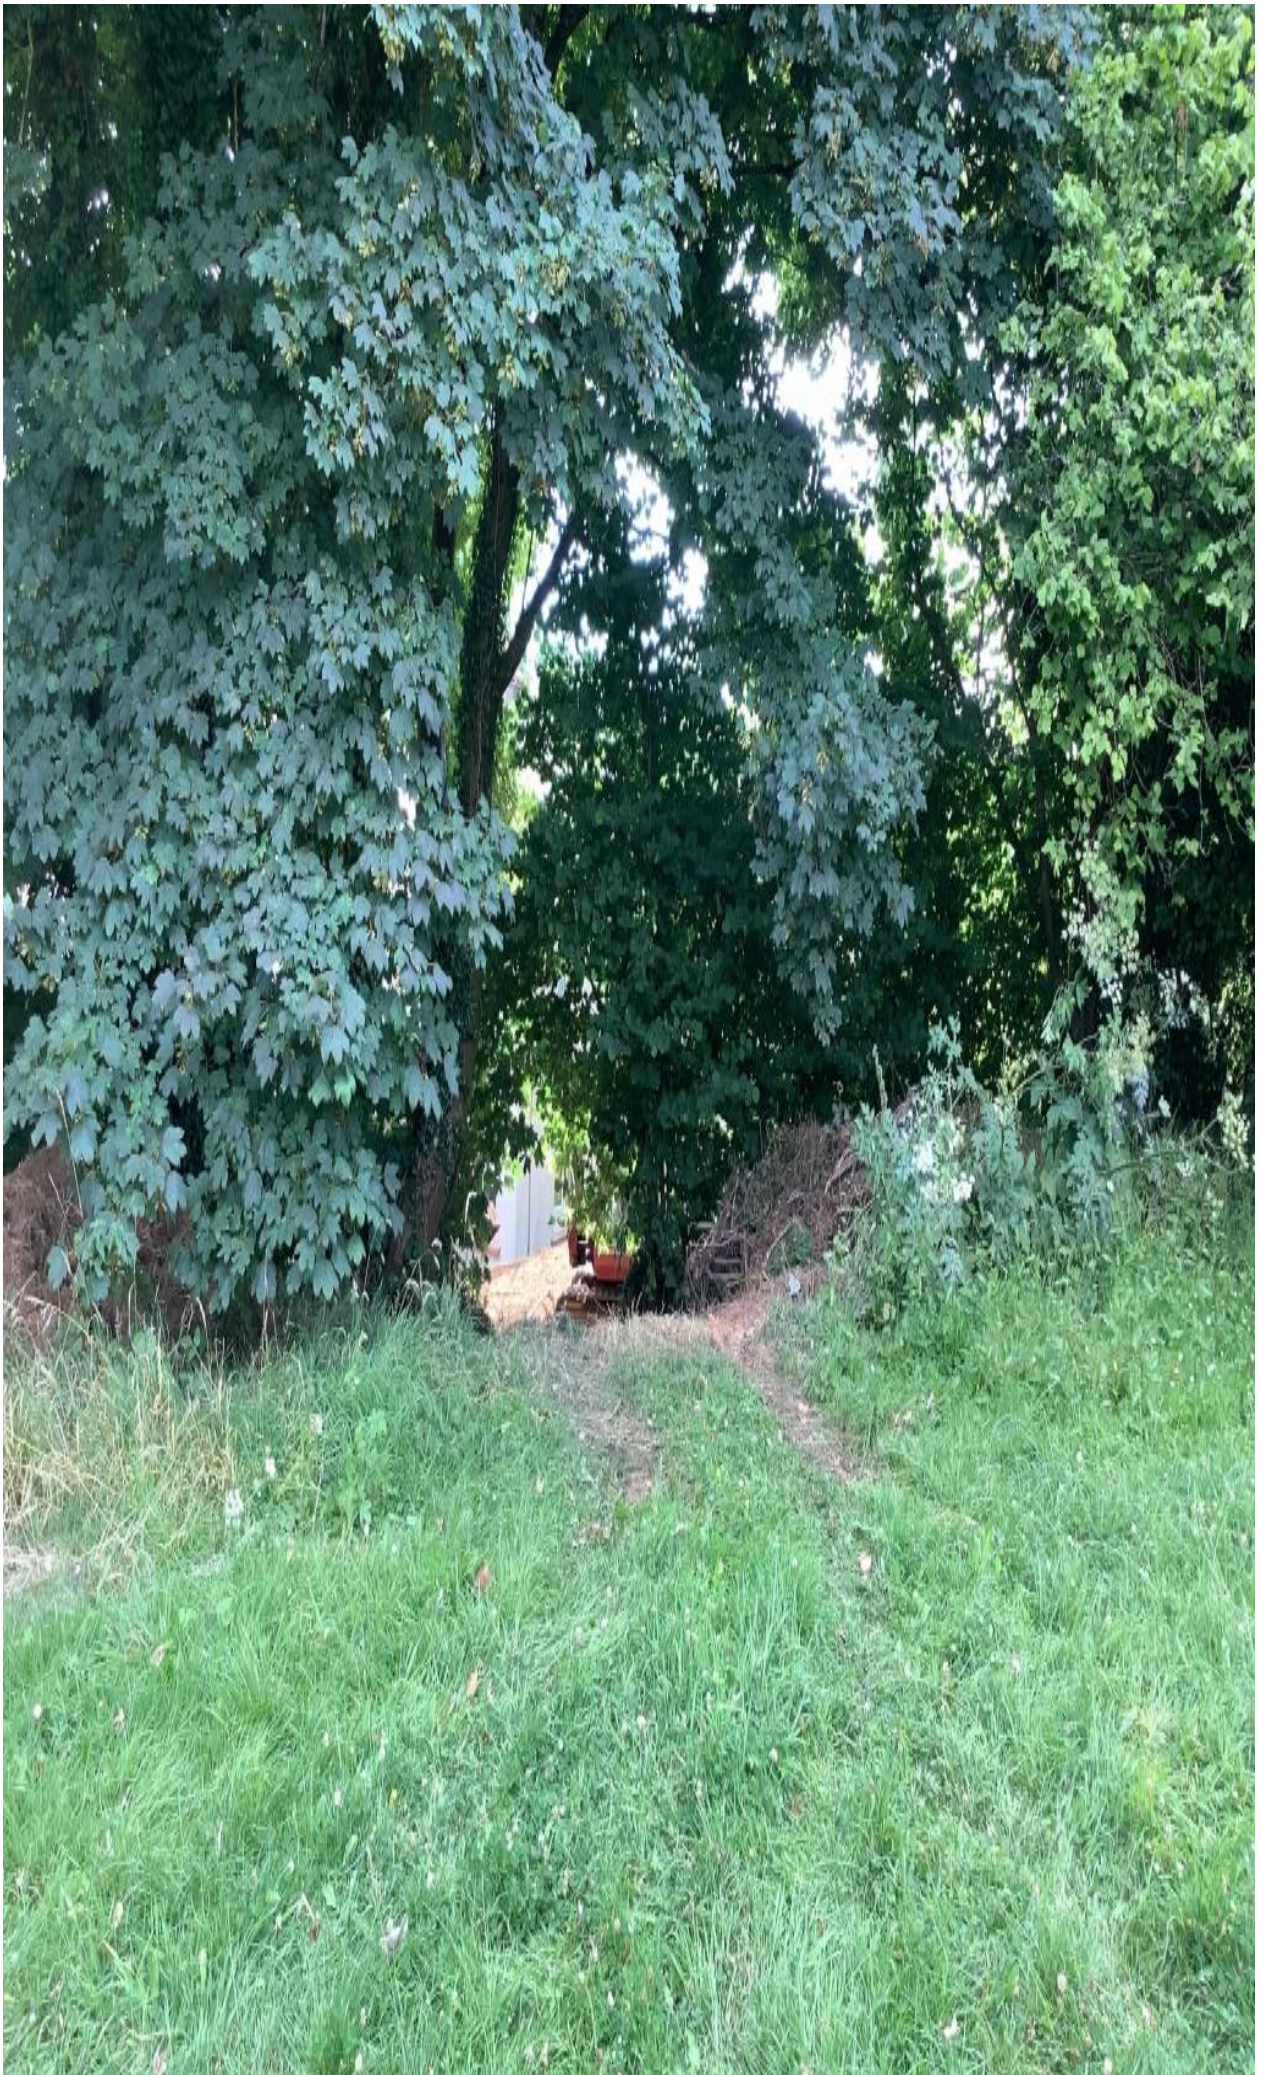
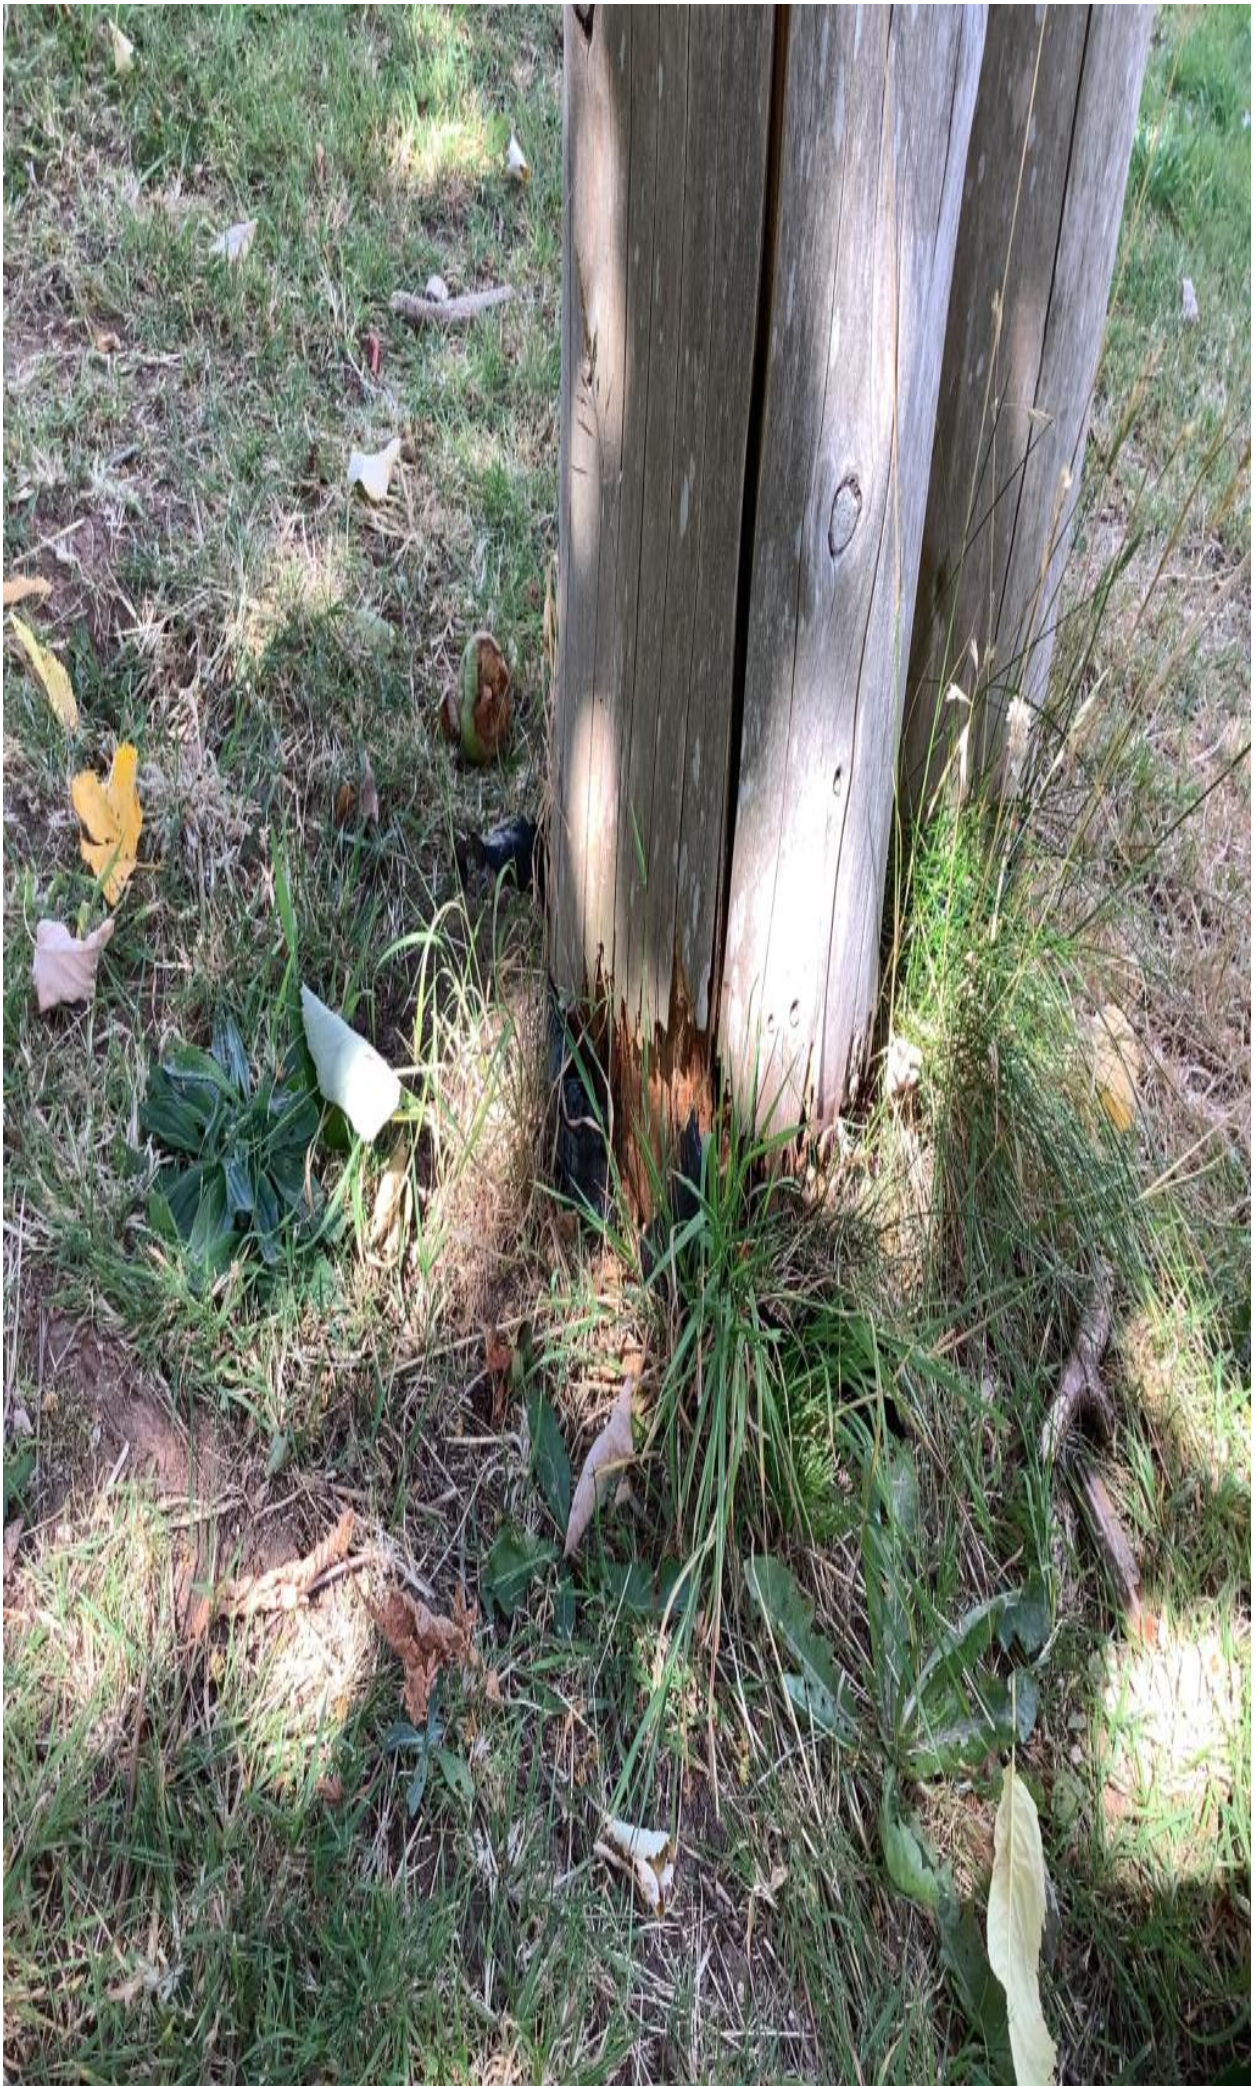
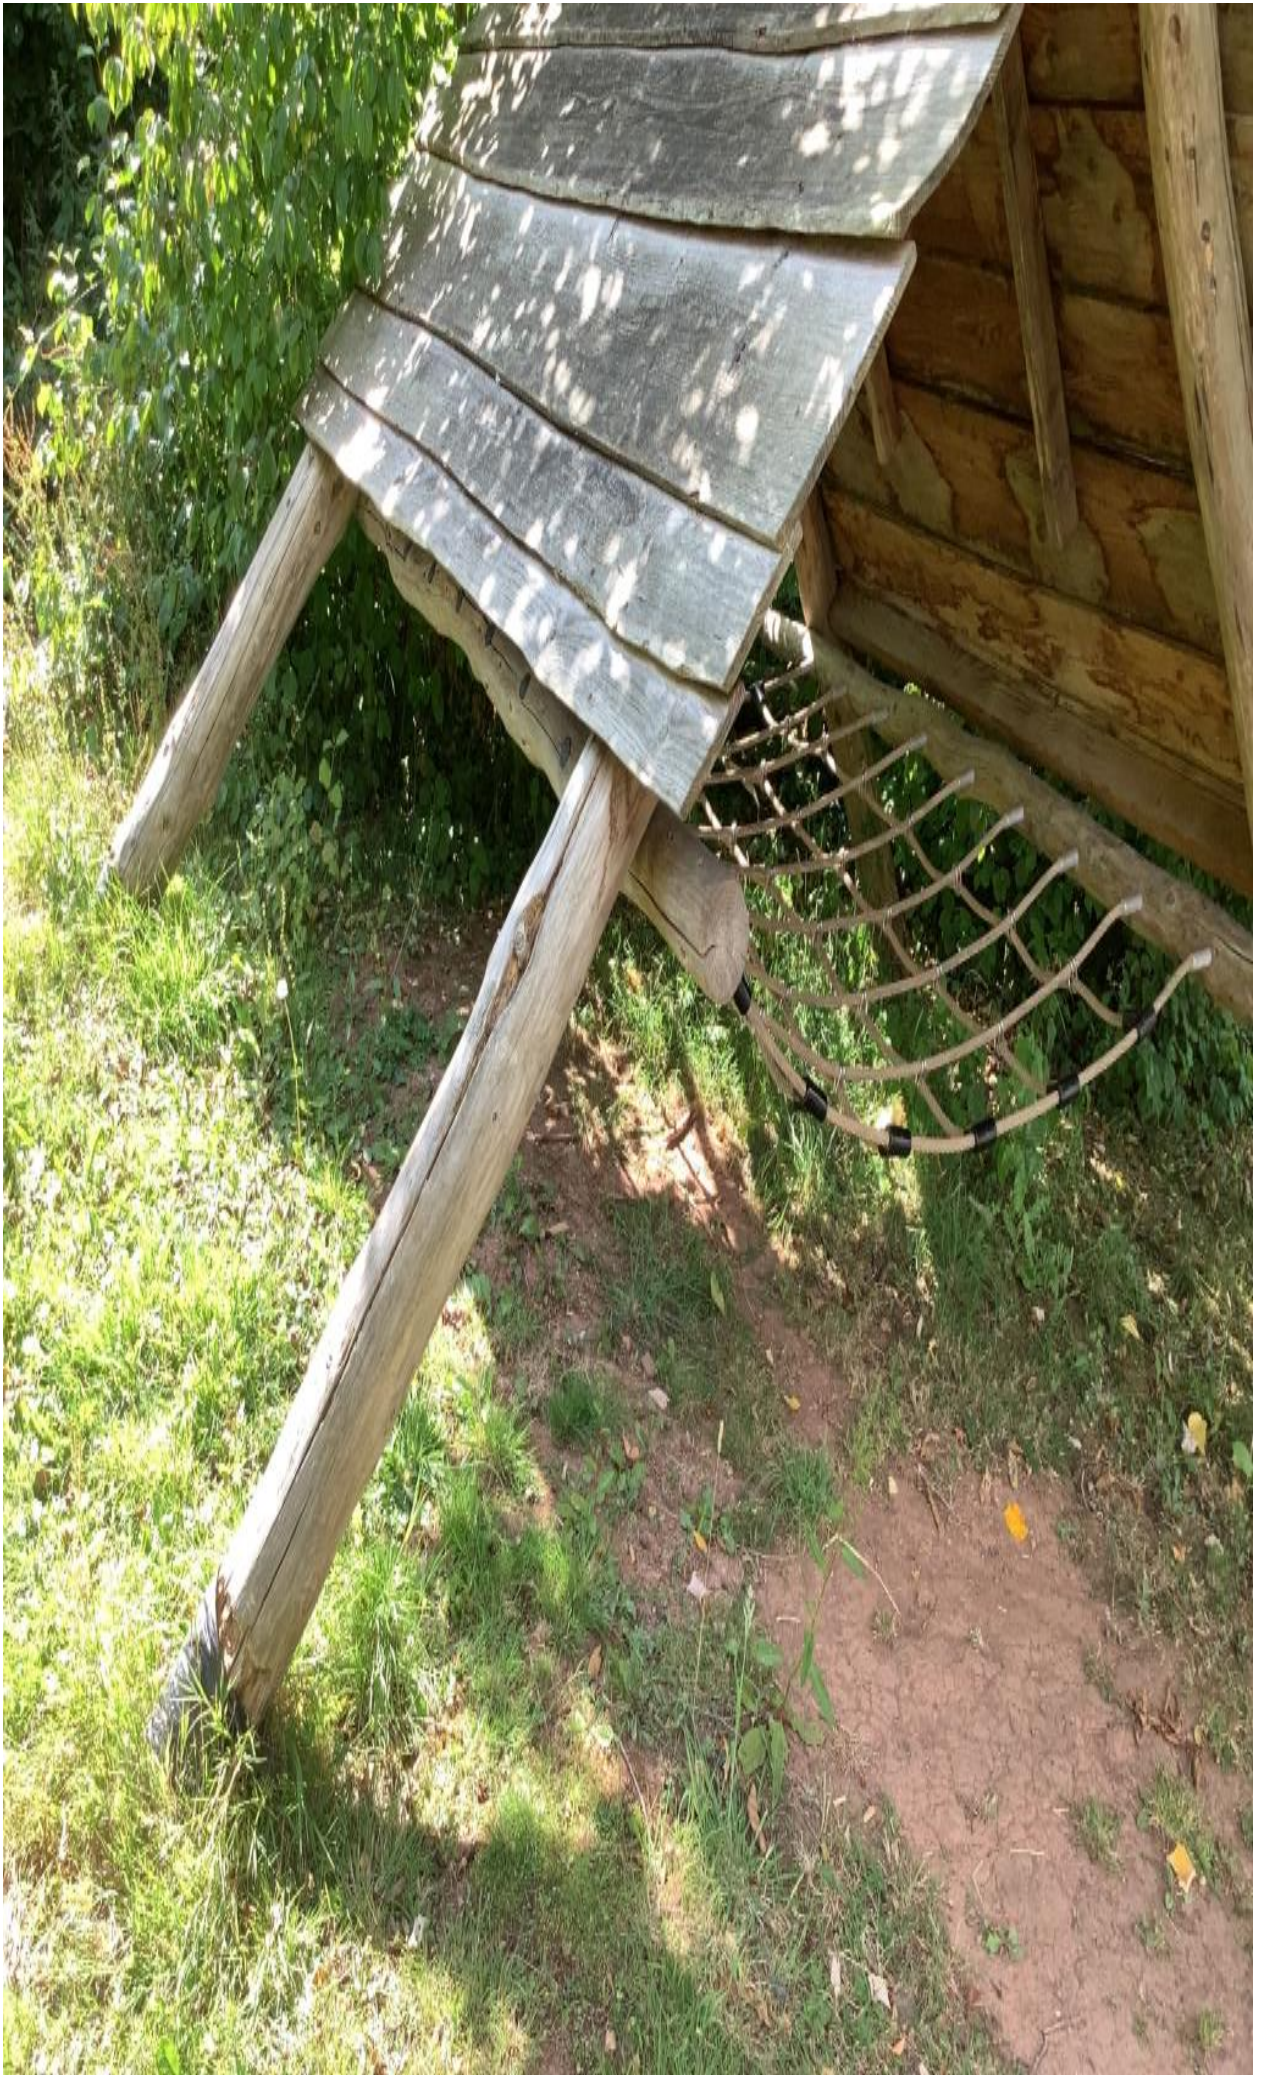
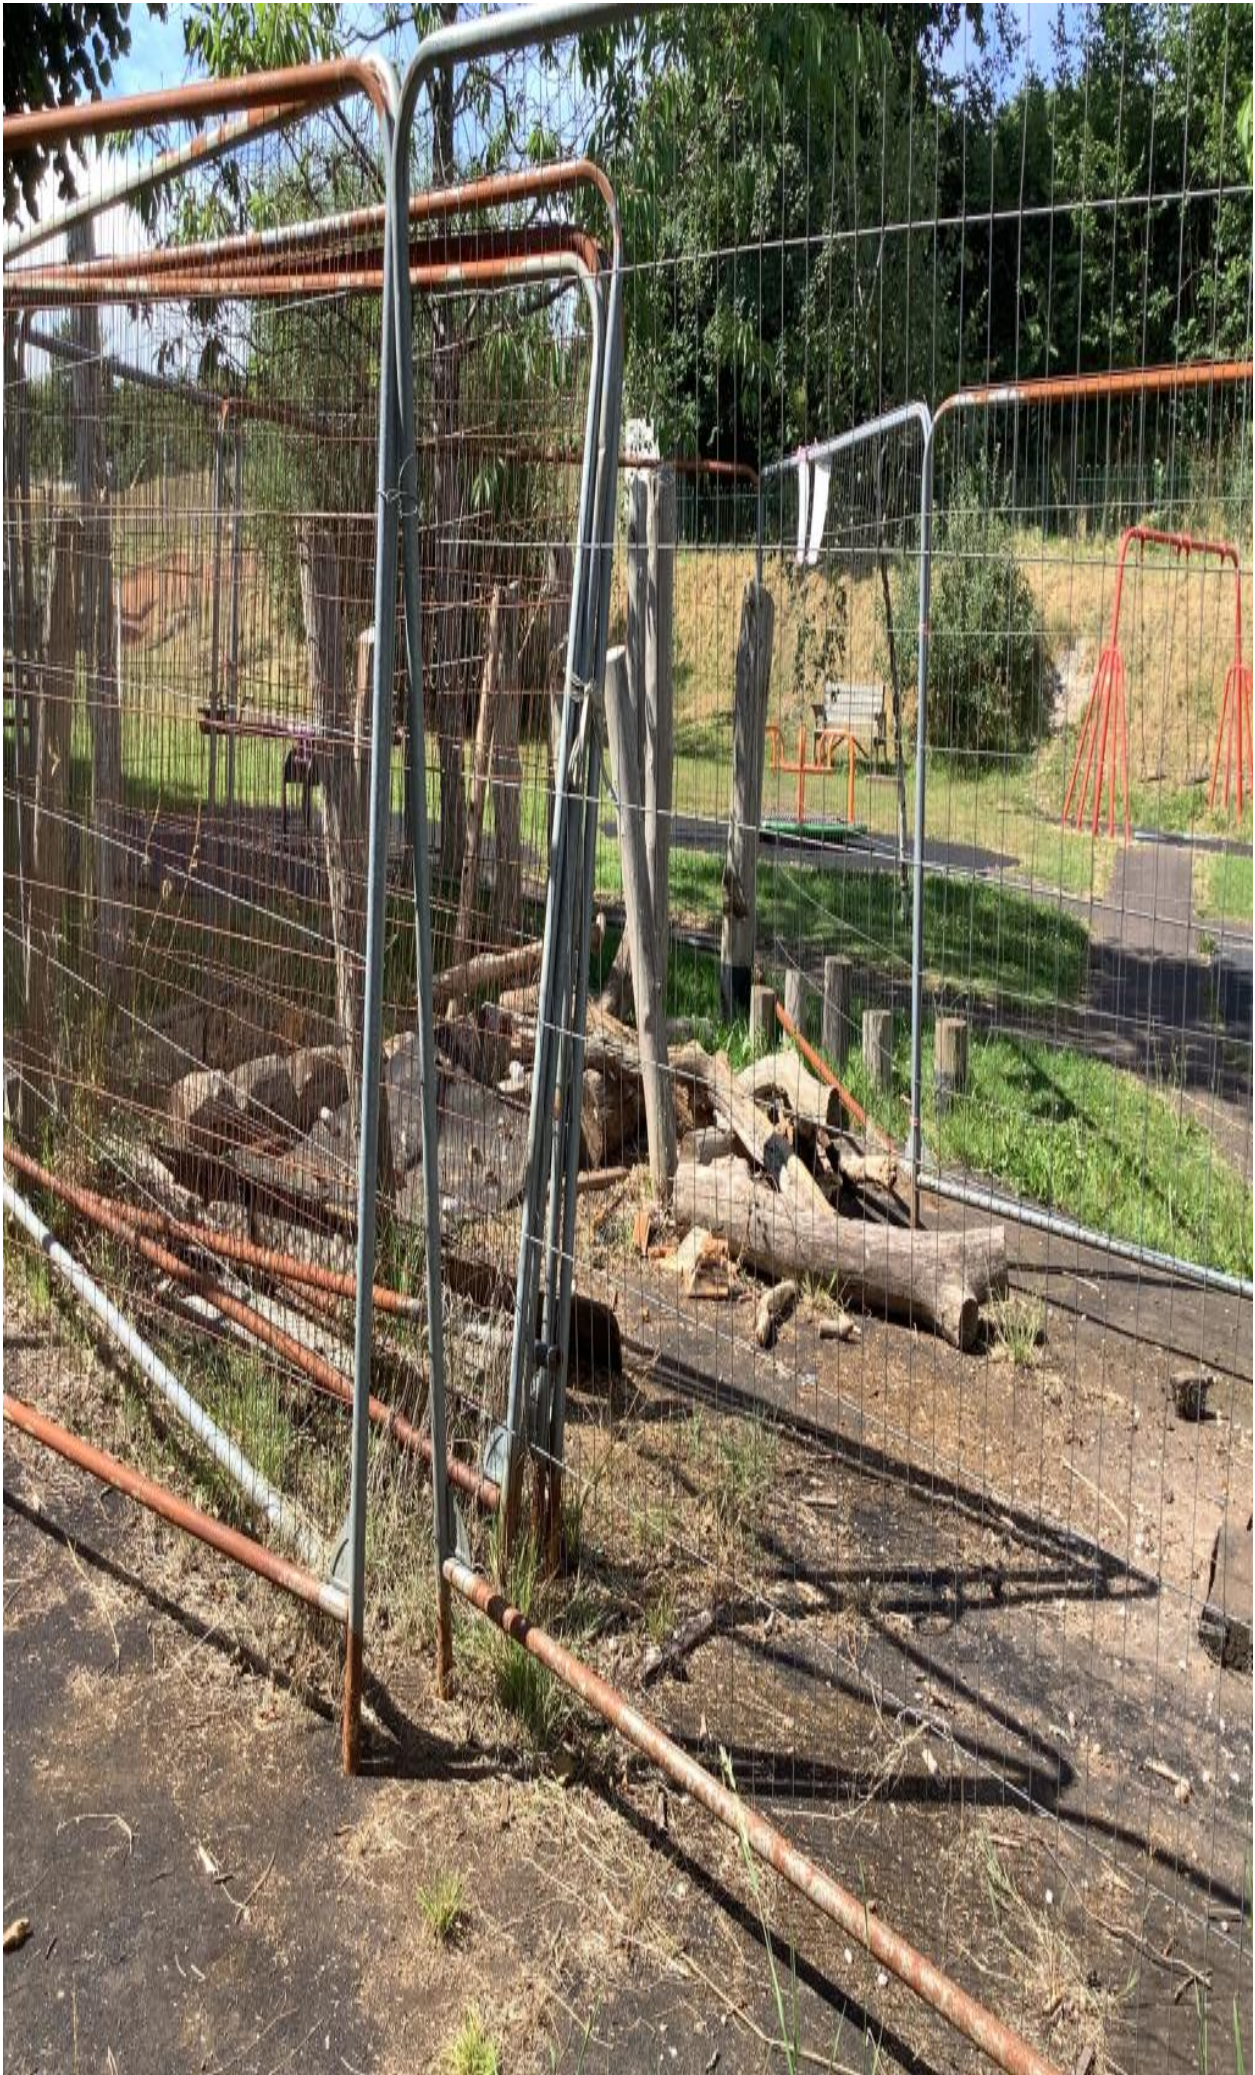
Entrance gate does not close fully.
Sprung tortoise Split plastic on handles causing sharp edges.
Screw sticking out of bench.
Access made into private gardens below park so park no longer Secure.
Gaps in rubber safety matting and rubber matting lifting causing trip hazard.
Rotten posts on high monkey bars .
Rotten posts on Hammock climbing frame.
Broken climbing frame Badly fence.
