South Hams / West Devon Park Inspection Report

Ref: AOM3492406

Site name: Harbertonford

Date of Inspection: 27/07/2022

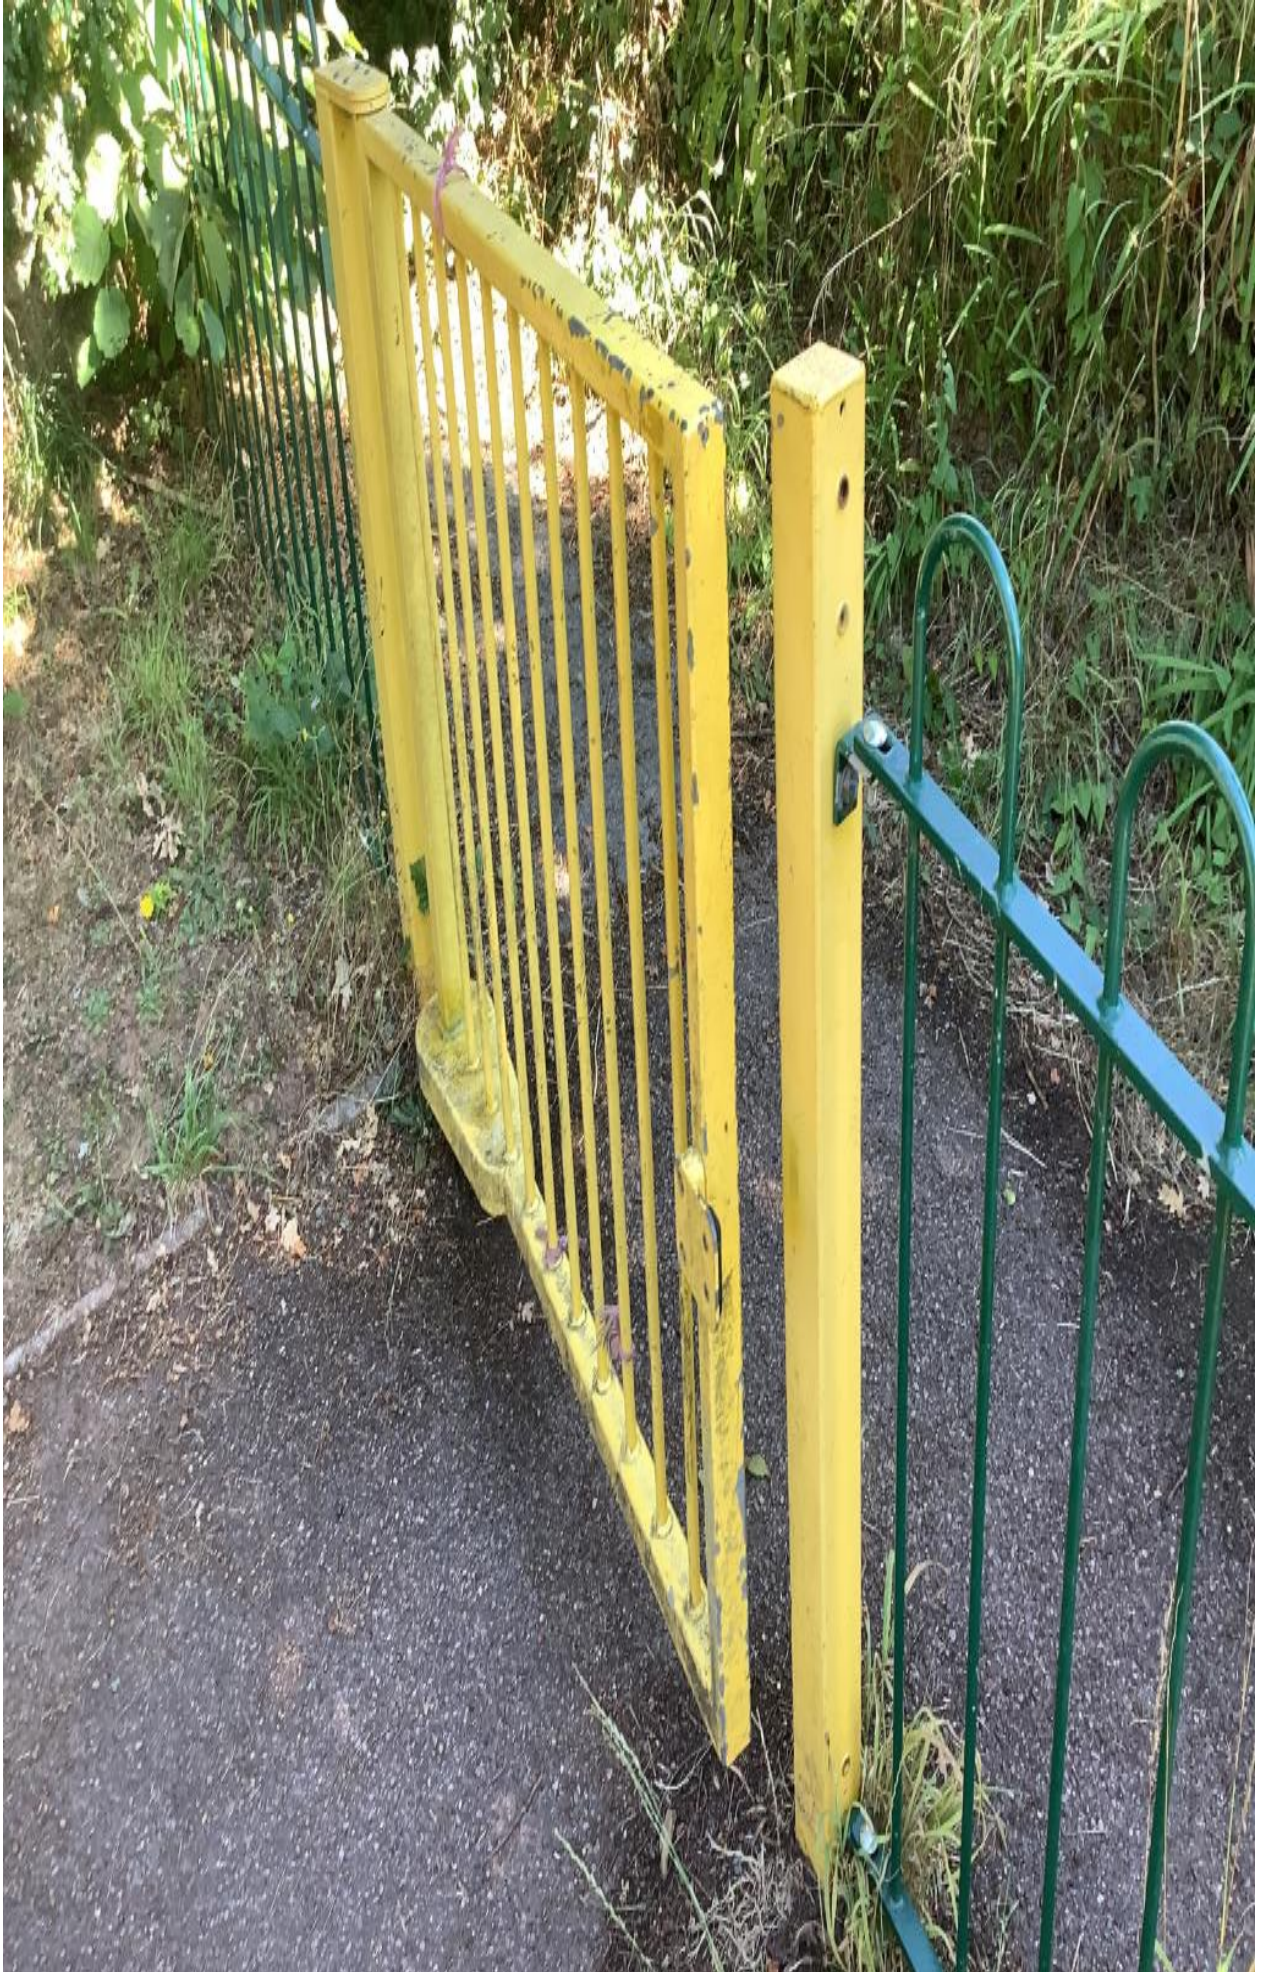
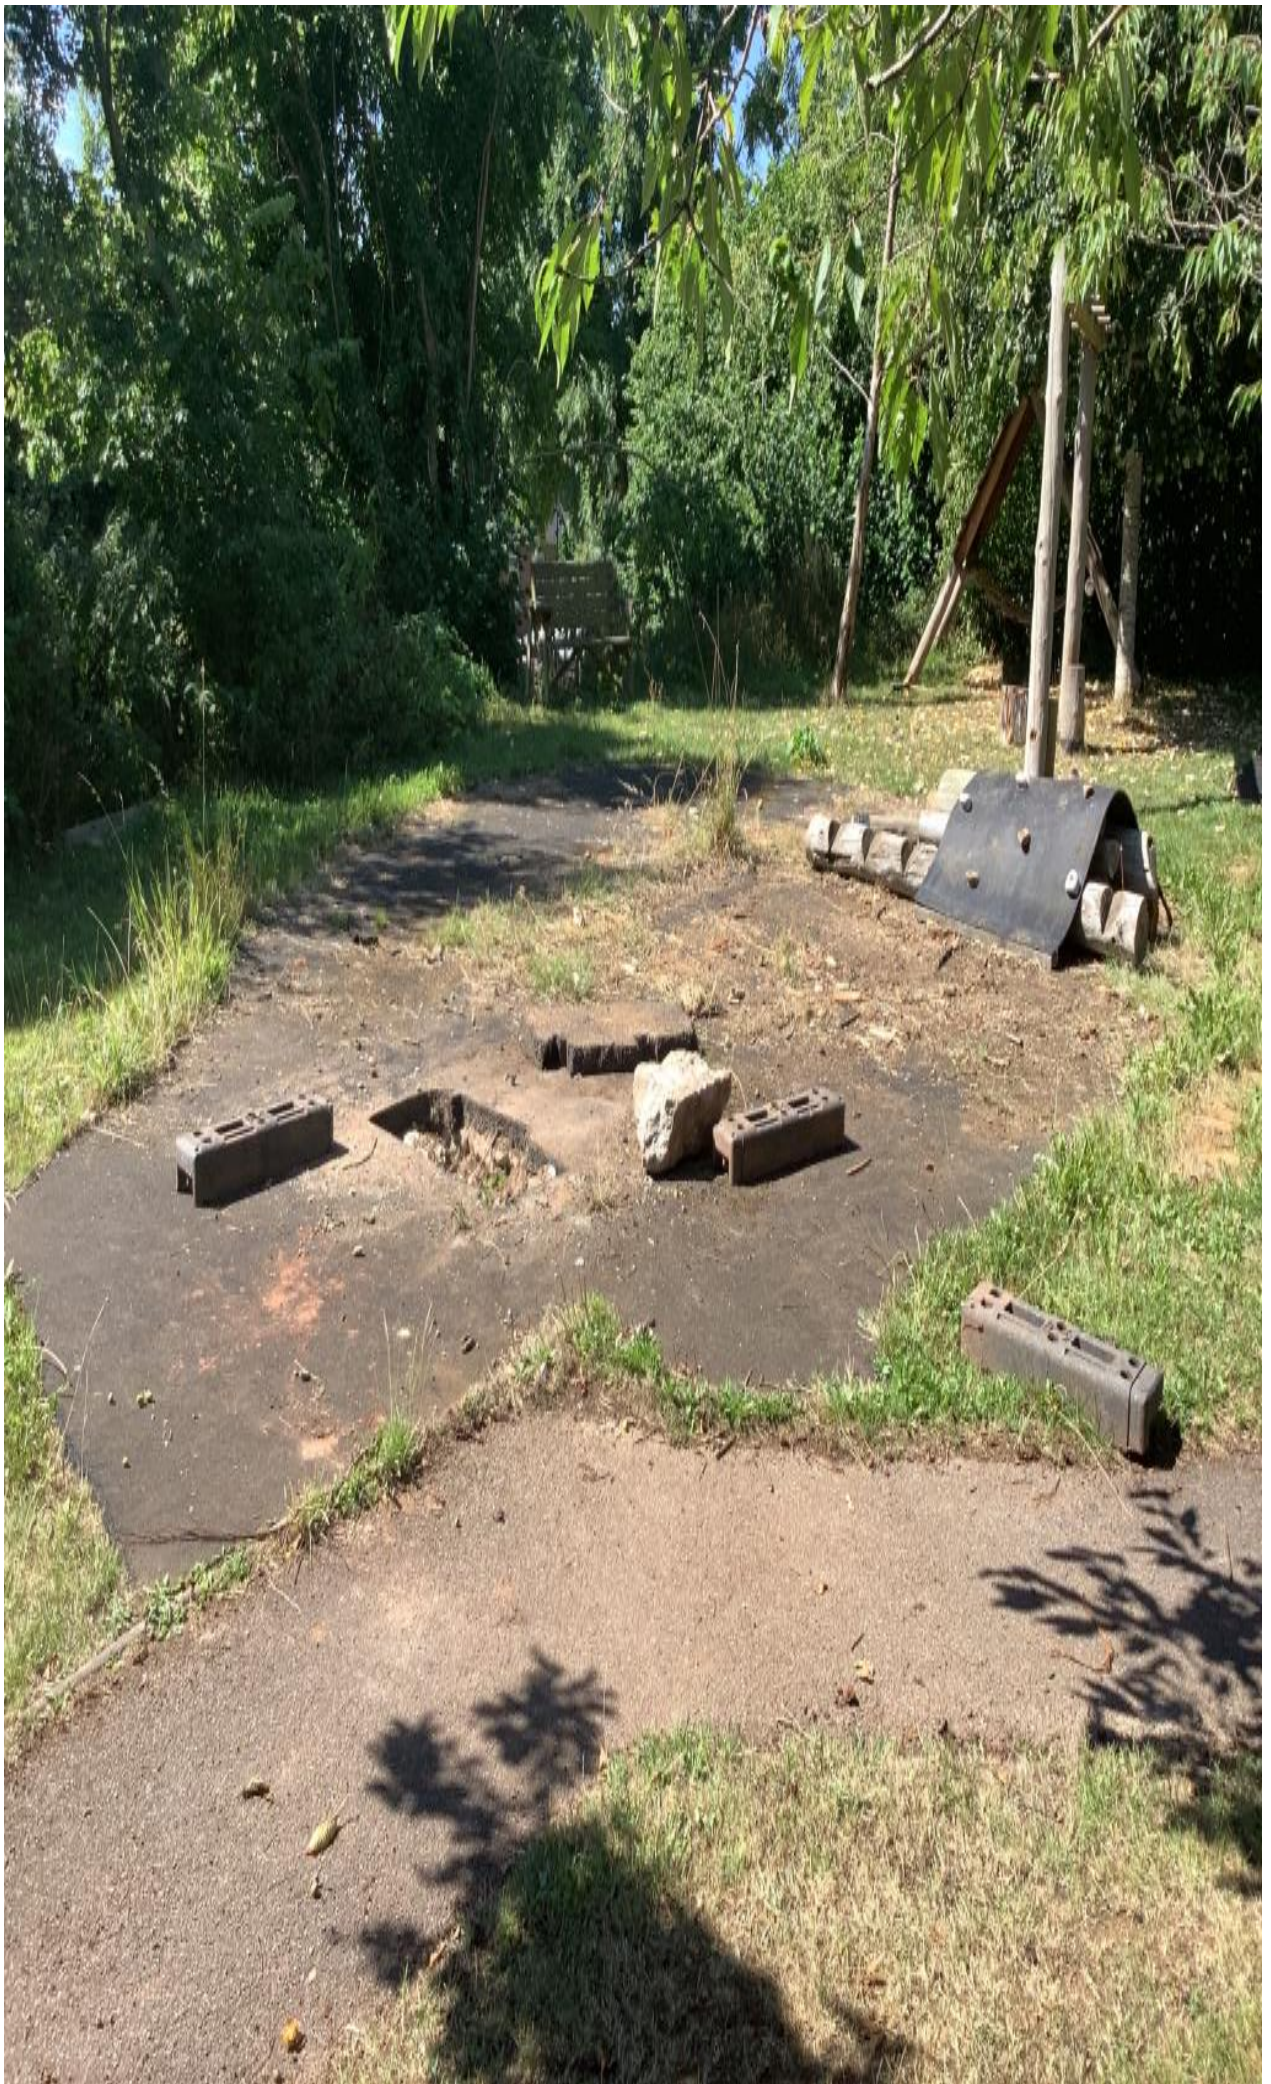
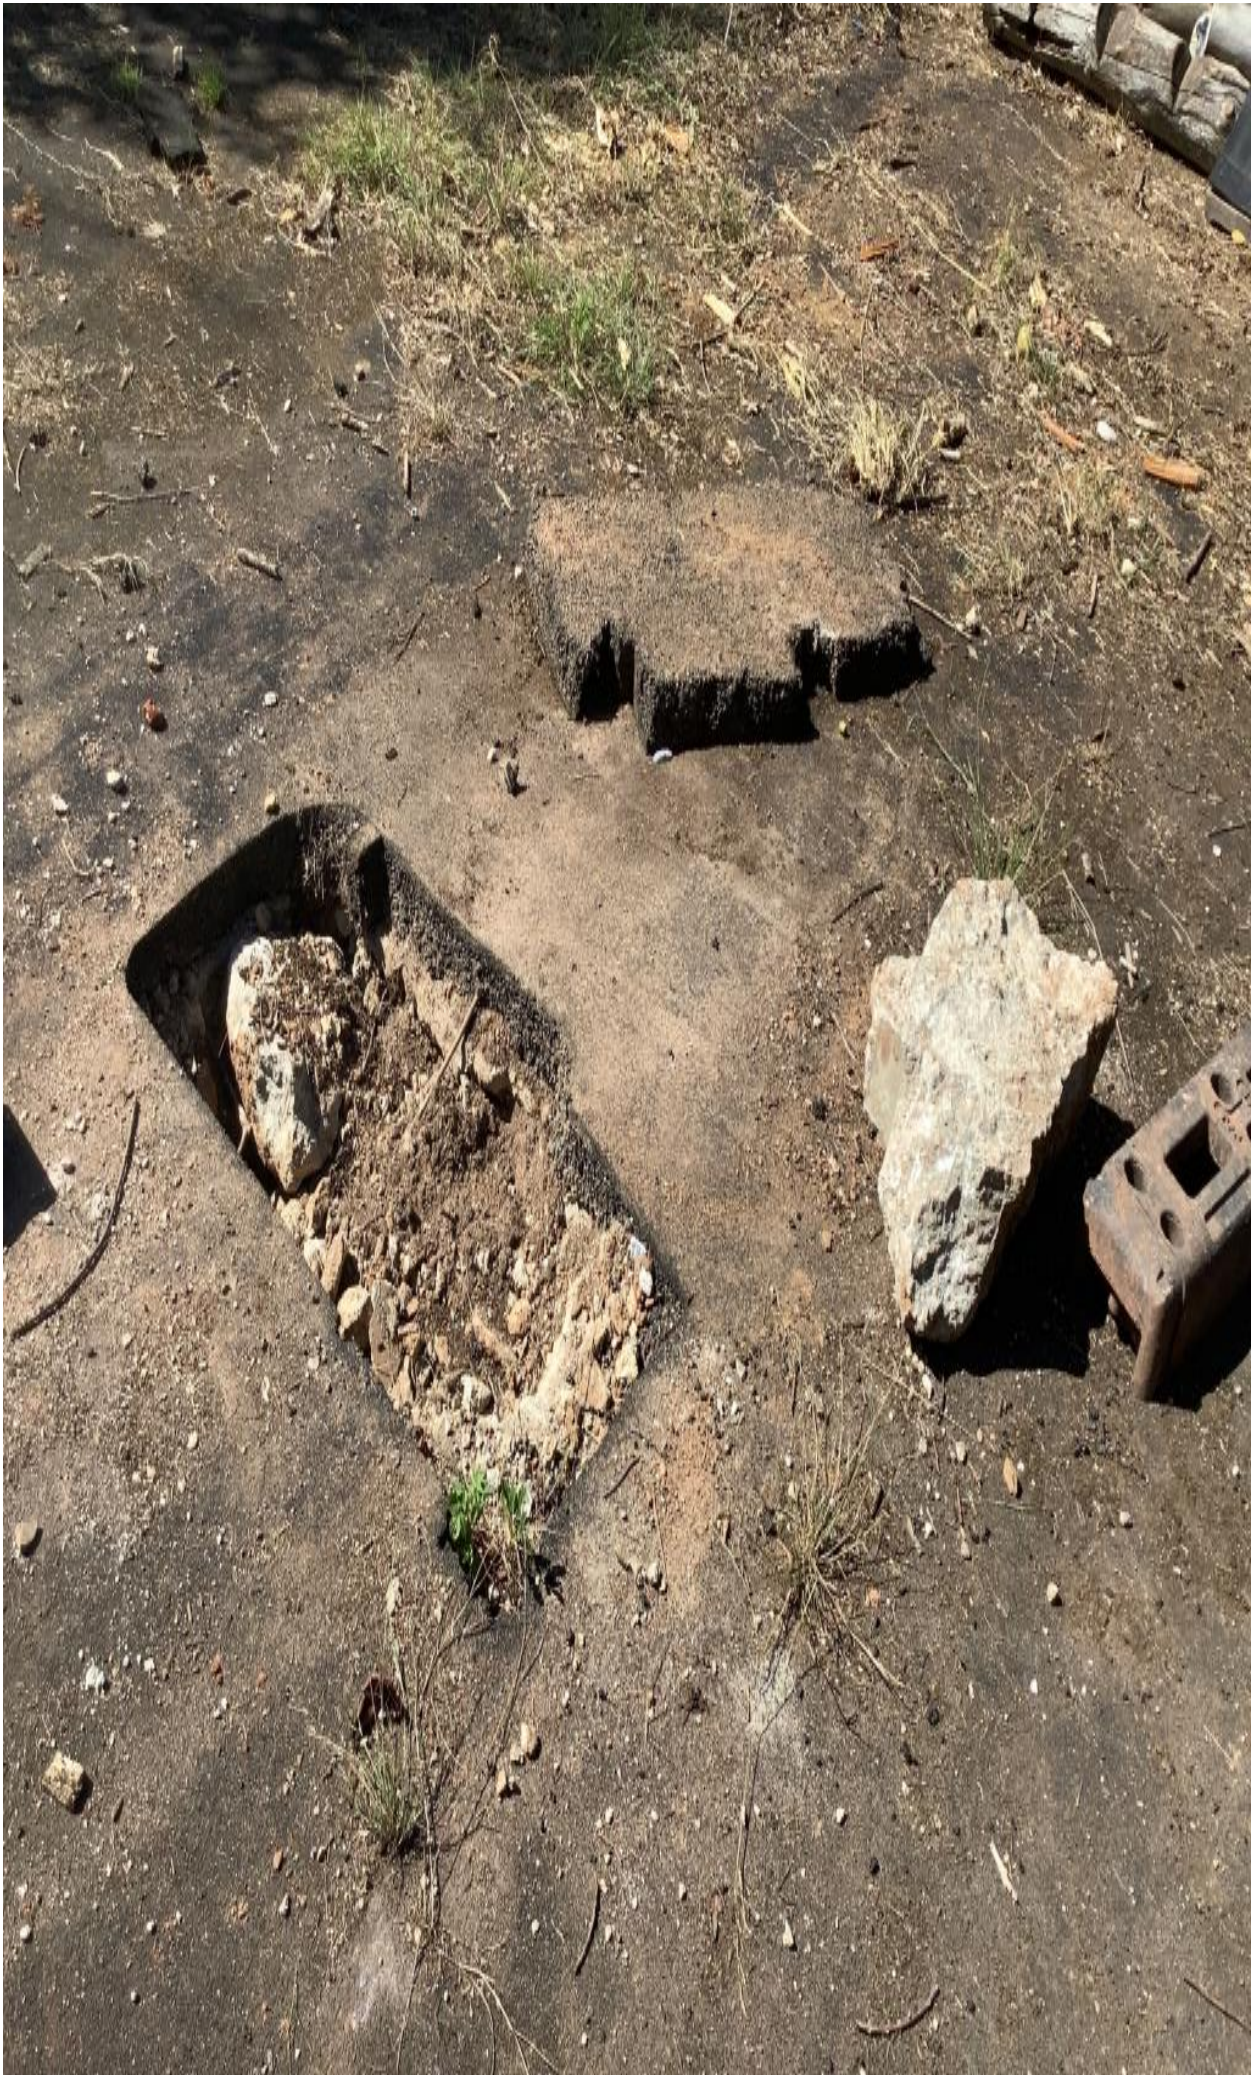
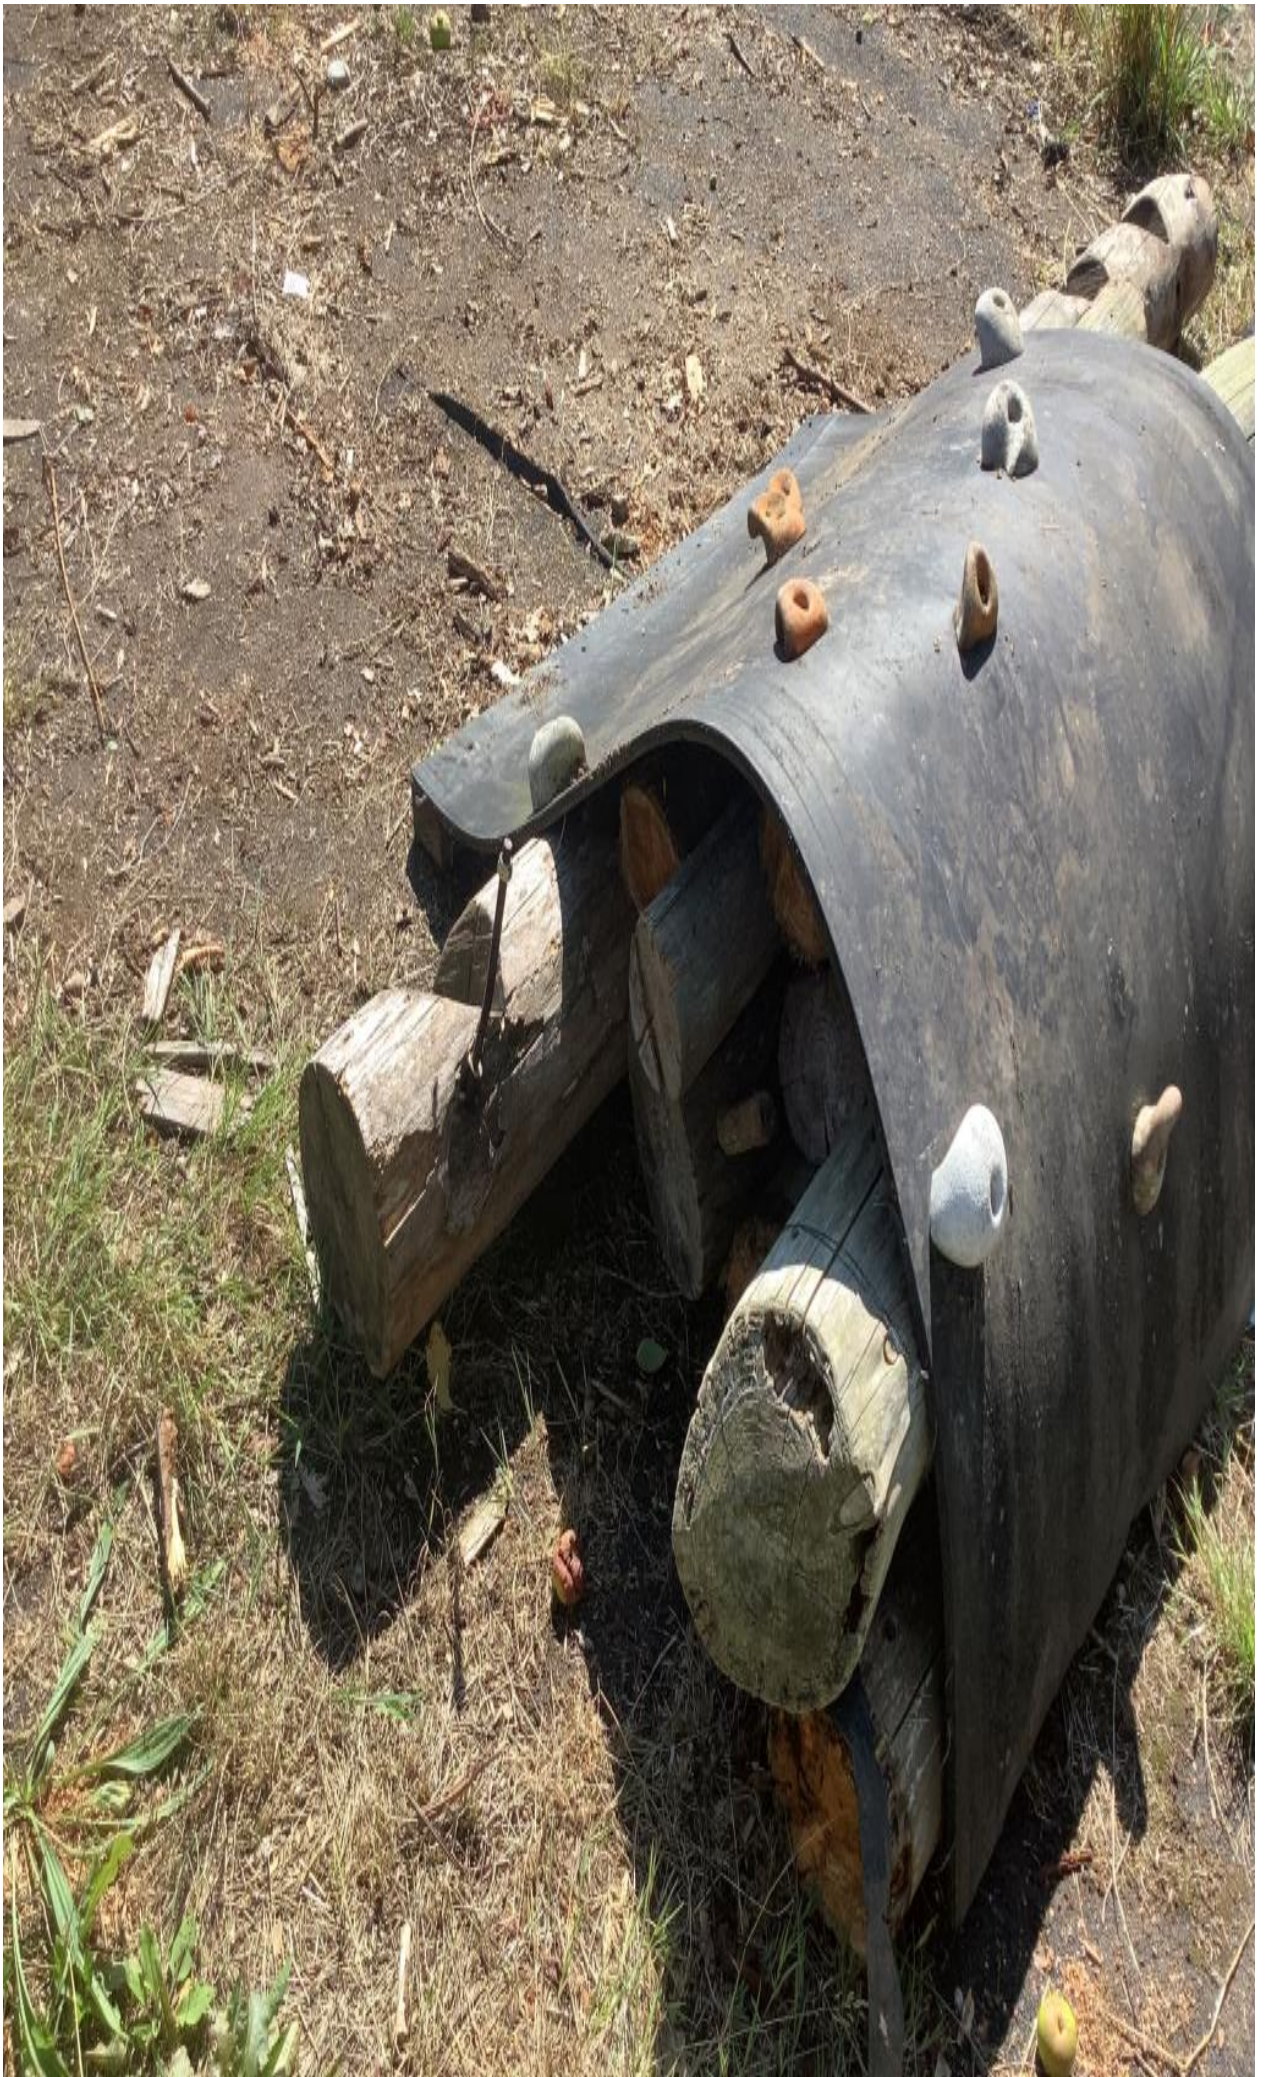
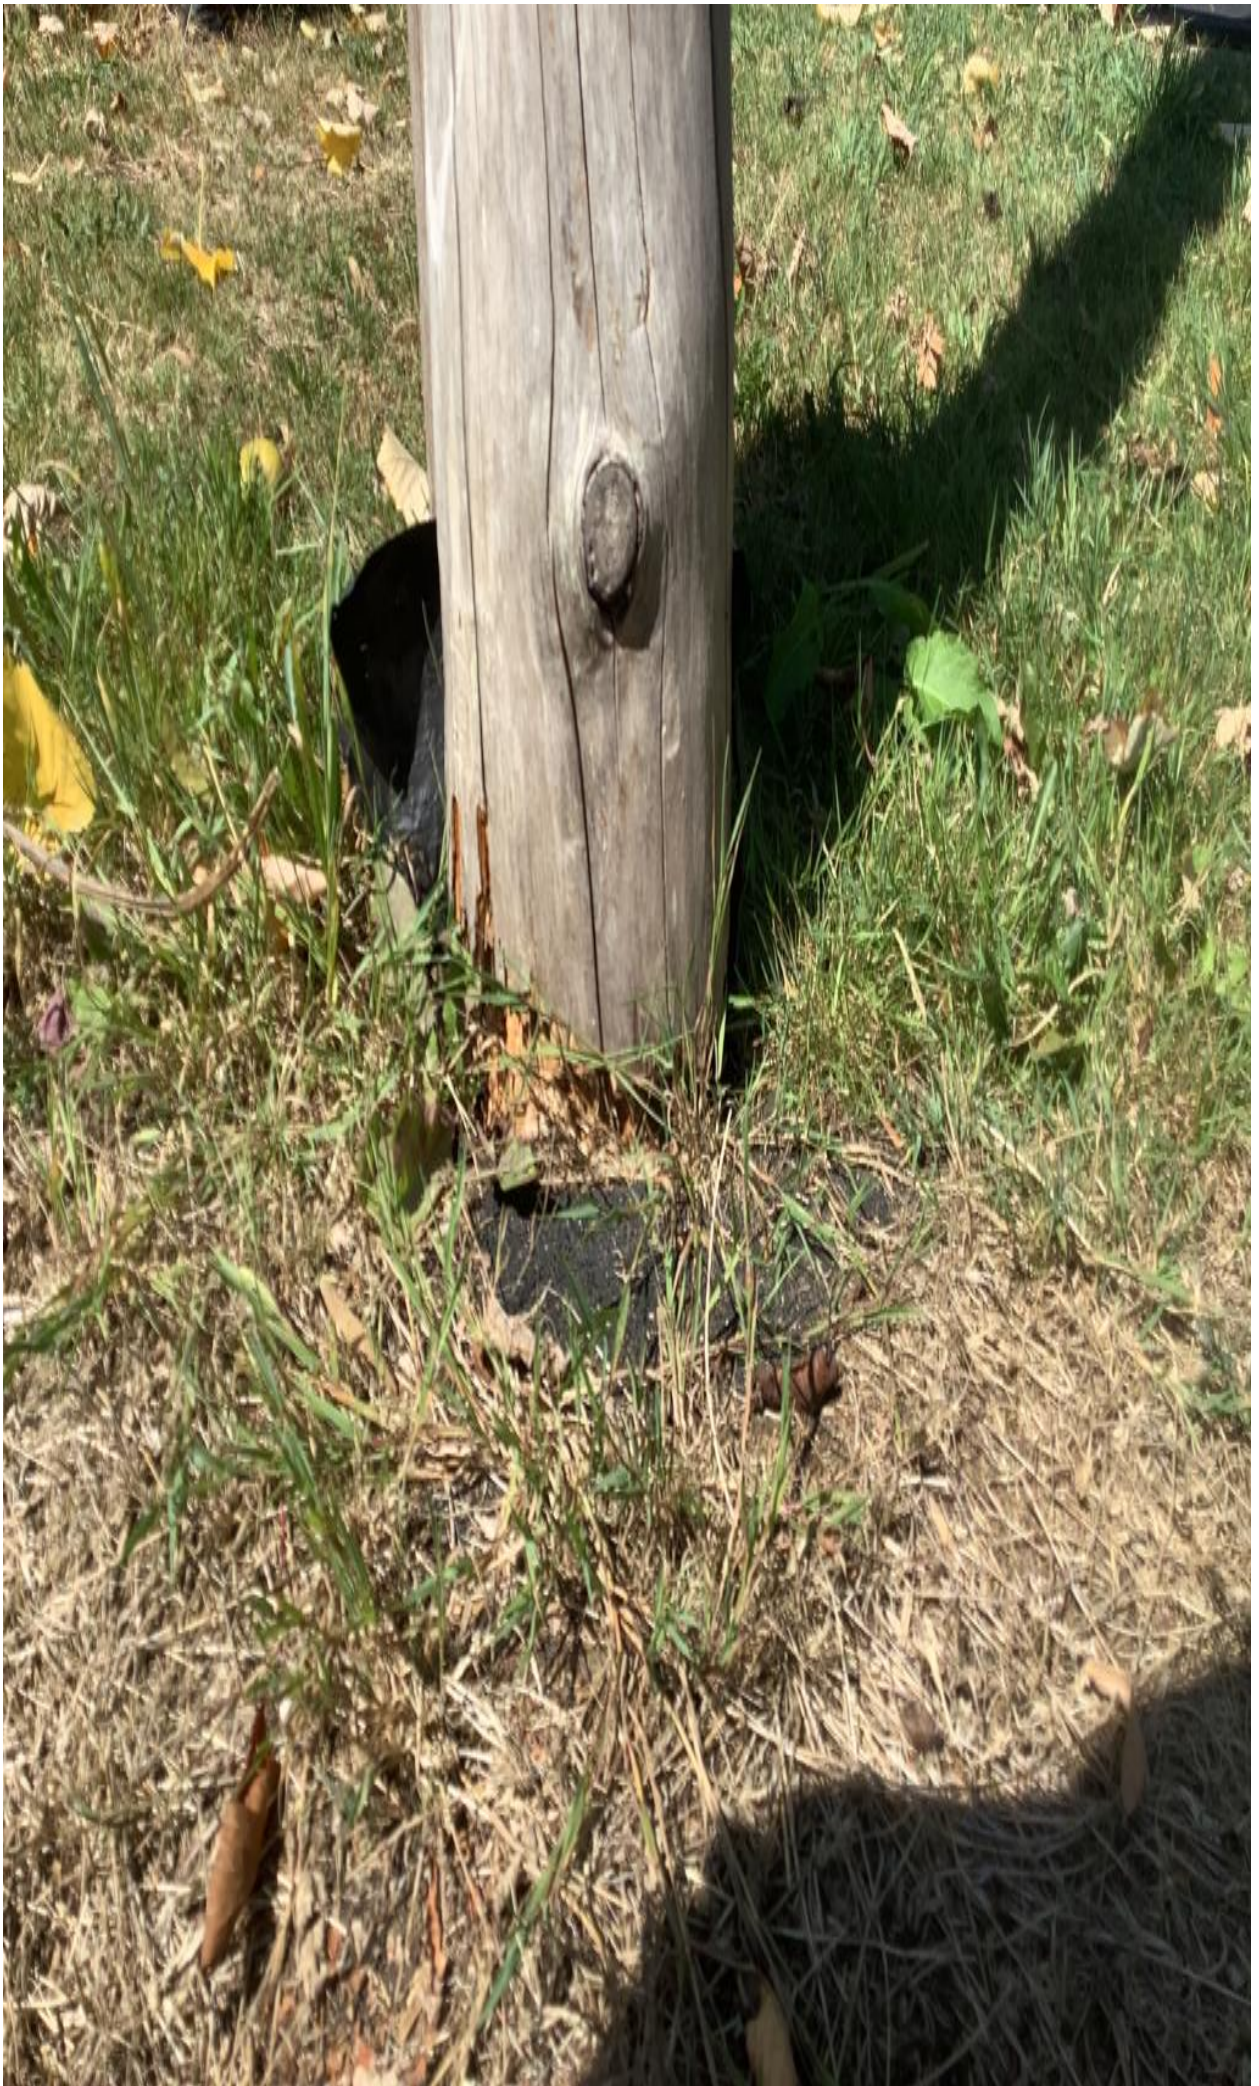
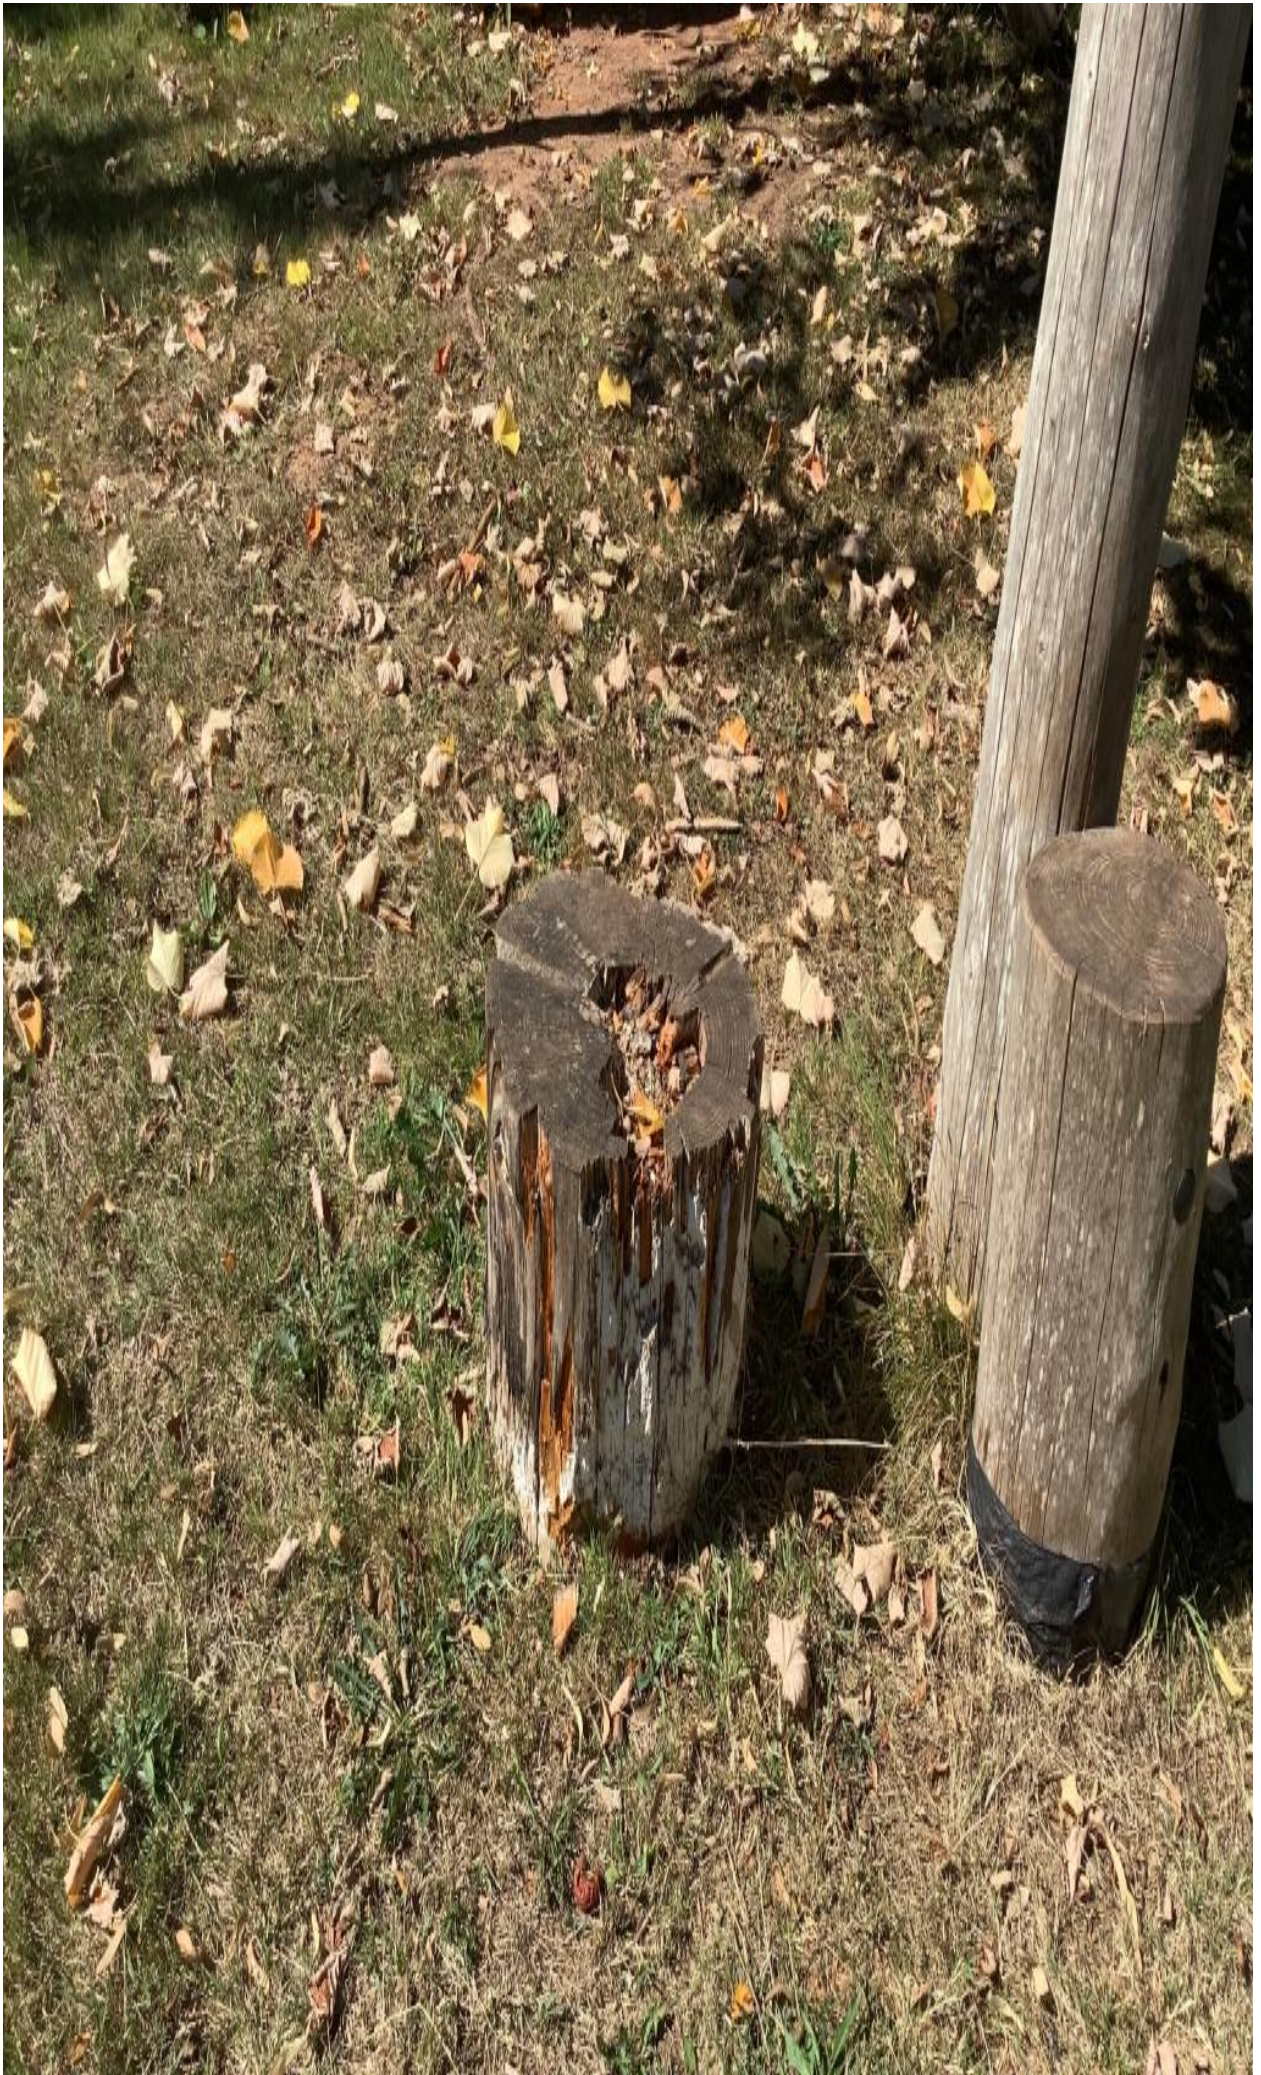
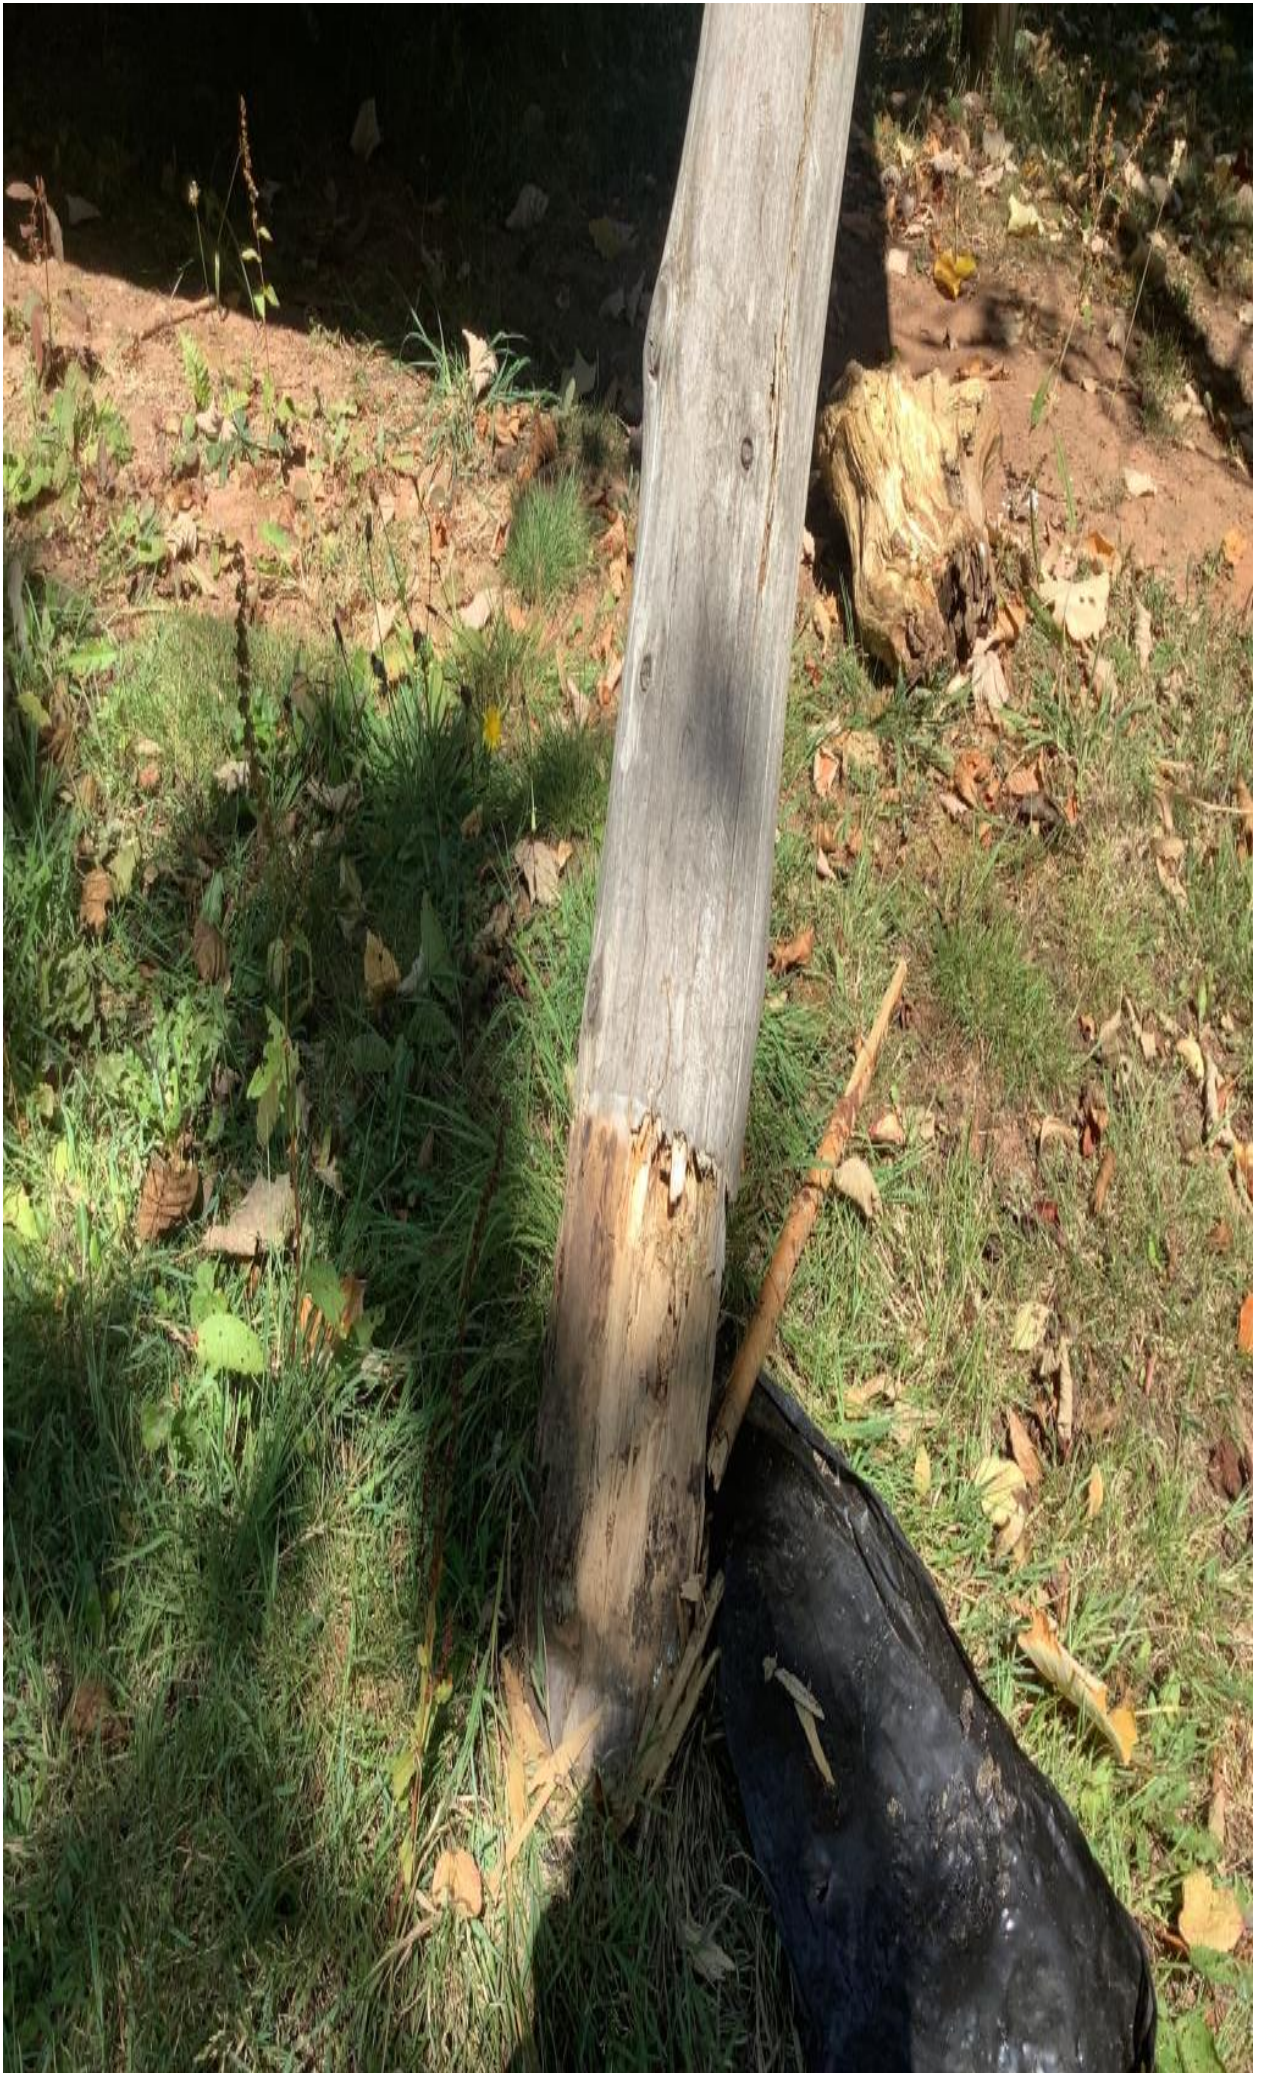
Gate Does not close fully.
Removed play park equipment left dangerous as is safety matting.
Rotten posts on monkey bar frame.
Sharp edges on rotten wooden stumps.
Rotten framework on wooden shelter.
Rubber safety matting lifting around edges.
No fencing around lower part of play park making it no secure and drop in bank . also there is open access to private gardens .
